WELL CONTROL INCIDENT ANALYSIS

EOG Resources Inc.

Punxautawney Hunting Club 36H

July 2010

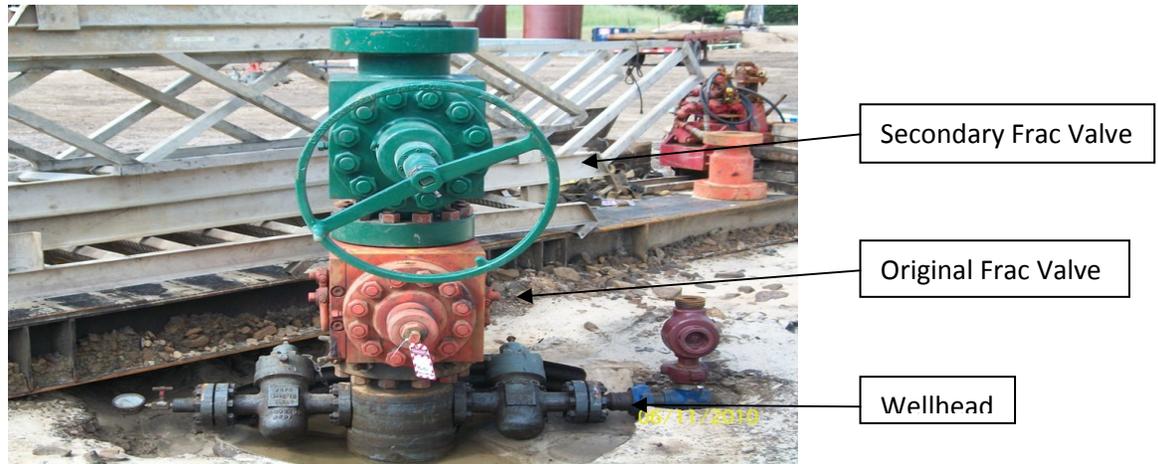
5-1/8" – 10,000 psi WP Frac Valve

The lower orange valve is the original 5-1/8" – 10,000 psi WP frac valve which was installed prior to the frac on the wellhead and remained in place during the well control incident. It is a full opening valve and requires 33 rounds to fully open or close the valve. The hand wheel has been removed.

The upper green valve was installed after the removal of the flow cross and BOPS after the well control incident was secured. This was done for safety reasons in the event the lower valve failed.

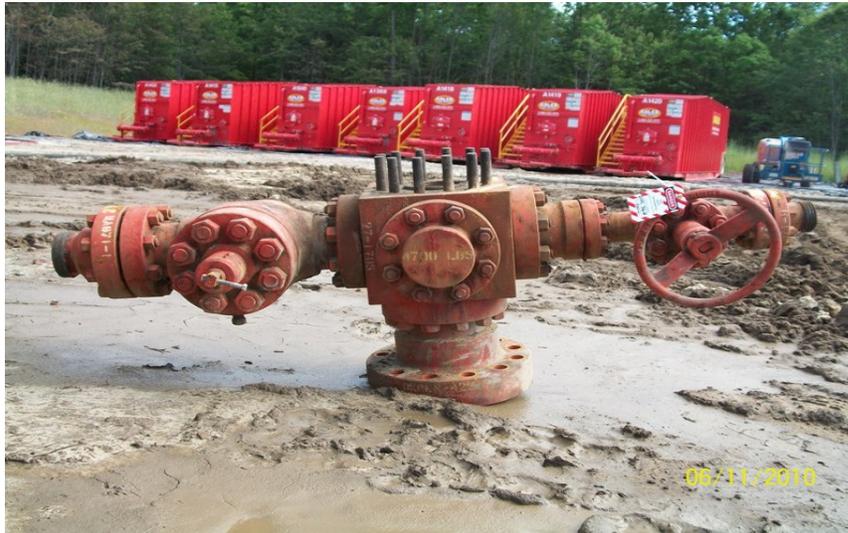
5-1/8" – 10,000 psi WP Flow Cross

The 5-1/8" – 10,000 psi WP flow cross was installed on top of the frac valve before starting the post-frac cleanout operations. The cross allowed frac fluid and brine to be flowed up the 5-1/2" casing x 2-3/8" tubing annulus.

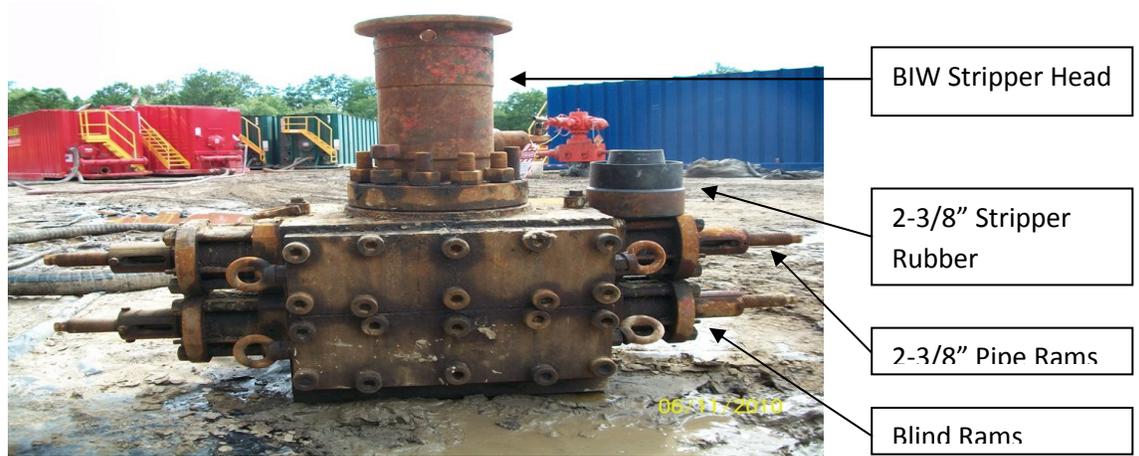
7-1/16" – 5,000 psi WP Dual Ram BOP

BIW Stripper Head and 2-3/8" Stripper Rubber

The 7-1/16" – 5,000 psi WP Dual ram BOP with Beaumont Iron Works (BIW) stripper head was installed on top of the 5-1/8" – 10,000 psi WP flow cross. A cross – over was required for proper make-up. Blind rams were installed in the lower rams and 2-3/8" pipe rams were installed in the upper rams.

The BIW stripper head has a 7-1/16" – 5,000 psi WP flange so it can bolt up to the BOP. The 2-3/8" stripper rubber is not pressure rated by the manufacturer due to the fact that as soon as it is used it would be downgraded because of wear. Therefore, it cannot be considered a pressure barrier during workover operations.

During the post-frac cleanout of the EOG PHC 36H well, only one acceptable barrier was in place once the 2-3/8" tubing was run into the well. The 7-1/16" – 5000 psi WP 2-3/8" pipe rams were the only true barrier between the producing zone and the atmosphere. The BIW stripper head with installed stripper rubber should never be considered a barrier because it has no recognized manufacturer's pressure rating and from the moment of first use, it would be downgraded due to wear. The wear on a stripper rubber is dependent on the condition of the pipe run through it or rotated in it (i.e. – wear is more extensive if the pipe is highly pitted or has a large amount of scale). The other two potential barriers on the well during the cleanout were the blind rams and frac valve which were unusable once the 2-3/8" tubing was run in the hole. This is due to the pipe not allowing the frac valve or blind ram to close.

On the EOG PHC 36H, the decision to pull the 2-3/8” tubing through the 2-3/8” pipe rams after the stripper rubber (which should not of been considered a barrier) had failed, was flawed and ultimately led to the well control incident. This is especially true with +-1500 psi pressure underneath the pipe rams and 0 psi pressure between the pipe rams and failed stripper rubber.

1. The primary cause of the well control incident was the failure of EOG Resources to have proper pressure barriers in place for the post-frac cleanout operations that were in progress at the time of the incident. Only one barrier was in place, the 7-1/16" – 5,000 psi WP 2-3/8" pipe rams and once they were compromised, there was no back-up.

2. EOG wellsite personnel failed to protect or properly maintain the last pressure barrier, the 7-1/16" – 5,000 psi WP 2-3/8" pipe rams which directly led to their failure. All operations should have ceased once that barrier was reached until additional barriers were repaired or in this case, added.

3. The 7-1/16" – 5000 psi WP dual rams were not tested before use and improperly tested once well pressure was applied to them. This puts in question the condition of the blind and pipe rams before the operations started.

1. A minimum of two pressure barriers should be in place during all post-frac cleanout operations. Possible barriers could include the following:
 - a. Pipe ram preventer - multiple
 - b. Annular preventers

Stripper heads should not be counted as pressure barriers in any post-frac cleanout operation or any well activity.

2. Recorded test results (chart record) of any BOP equipment utilized in post-frac cleanouts should be on file at the wellsite or with the wellsite supervisor. This test should be performed immediately after the installation of the BOP equipment and before its use.

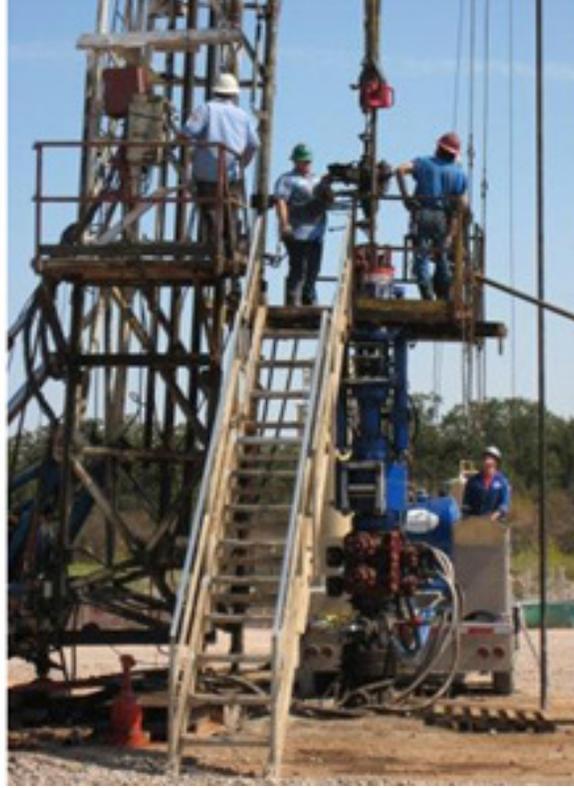
7-1/16" – 5,000 psi WP Rig Assist Snubbing Unit

A snubbing unit is designed to push or pull pipe from a well while under pressure. The units typically consists of a power unit, jack assembly, a 5,000 psi WP annular preventer and either one or two sets of ram type preventers. The rig provides the lifting capacity for the snubbing unit. Most rig assist snubbing units are truck mounted for ease of mob and de-mob.

Rig Assist Snubbing Unit – During the post-frac clean-out process on horizontal wells, the common practice is to utilize coil tubing to drill out the composite plugs between frac stages. EOG started the clean-out process with a 2” coil tubing unit and was able to drill up 11 of the 15 composite plugs in the hole. Due to friction between the coil tubing and the casing in the horizontal hole, the coil was not able to drill the remaining 4 plugs. EOG made the decision to use a workover rig, 2-3/8” tubing and a power swivel to drill up the remaining 4 plugs plus the upper composite plug used to seal off the open perforations while going in the hole. Using a rig and power swivel can be acceptable if proper pressure barriers are in place. However, a snubbing unit must be used after drilling out the composite plugs to pull the tubing from the well and to run in the hole with the production tubing. A much safer plan would be to rig up a rig assist snubbing unit once the coil tubing cannot go deeper in the well. This is true especially since a snubbing unit must be used anyway to finish the operation. While there would be a minimal additional cost, it would be a much safer operation as a snubbing unit is designed for the purpose of running and pulling tubing in a well under pressure.

4. A rig assist snubbing unit would have been a safer method of running the 2-3/8" tubing in the hole, drilling out the remaining composite plugs and pulling the 2-3/8" tubing out of the hole.

3. The use of a snubbing unit (stand alone hydraulic or rig assist) to perform post-frac cleanouts if coil tubing is not able to clean out the composite frac plugs and sand to total depth should be highly recommended. A snubbing unit is designed to run and pull tubing in and out of a well under pressure.
