## Gas Well Study, 2011

George Monk and Molly Schaffnit  
February 2012

Gas Well Study is the examination of natural gas wells in West Virginia in Kanawha and Putnam counties.

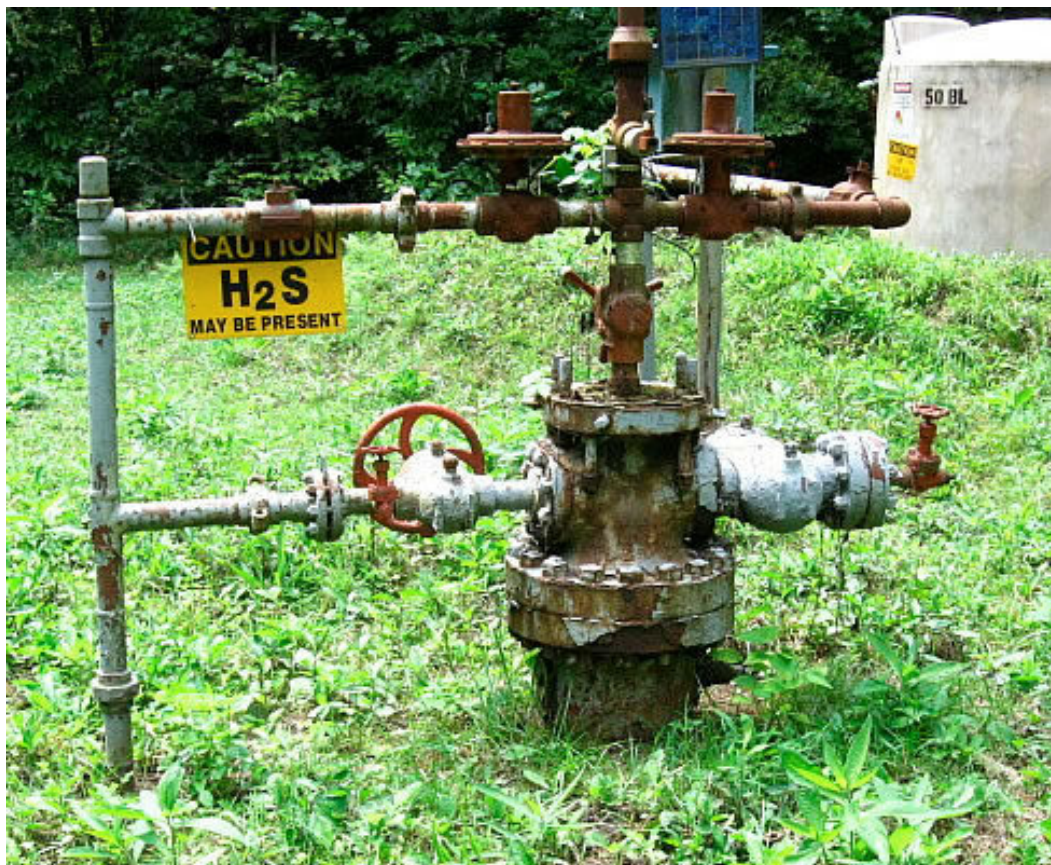
Wellhead and hydrogen sulfide warning sign for 47-039-02079 in the Kanawha State Forest. The plastic condensate storage tank sitting in its secondary containment is visible to the right. Note corrosion of casing head and production pipe. This site, like others in the state, had no security barriers to protect the public. Photo taken 29 August 2011.

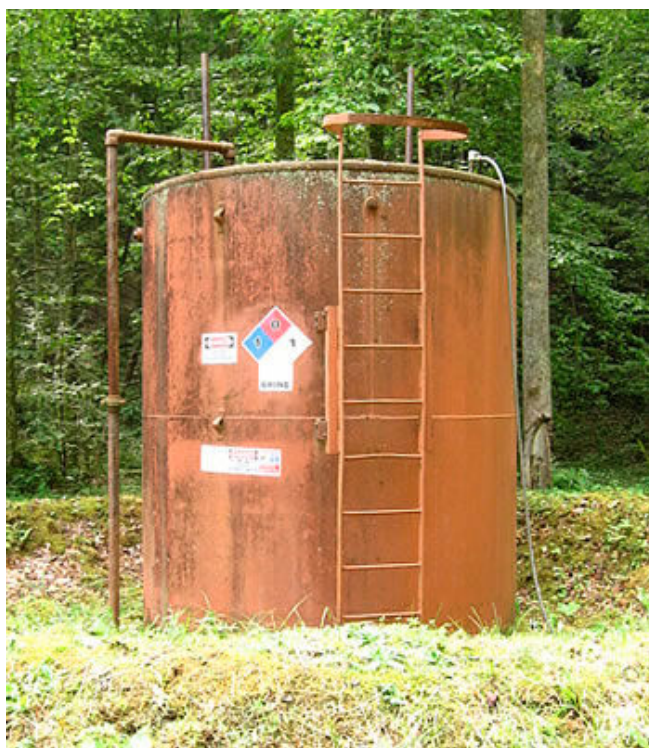
Photo 1. Condensate storage tank at 47-039-05500 well in the Kanawha State Forest. The overflow prevention device is visible at the top of the tank just to the right of the 10-foot high tank's ladder. Photo taken 29 August 2011.

Christmas tree metal work was unpainted.<sup>3</sup> There was secondary containment for the 100 barrel condensate storage tank (which had a solar powered overflow detection/prevention device). Secondary containment at this and other sites was being compromised by animal activity – a trail crossed the dike, eroding its height.<sup>4</sup> There was no security barrier for this well which is next to a popular hiking, horseback riding and mountain biking trail. The ladder for the tank, especially, is an attractive nuisance.

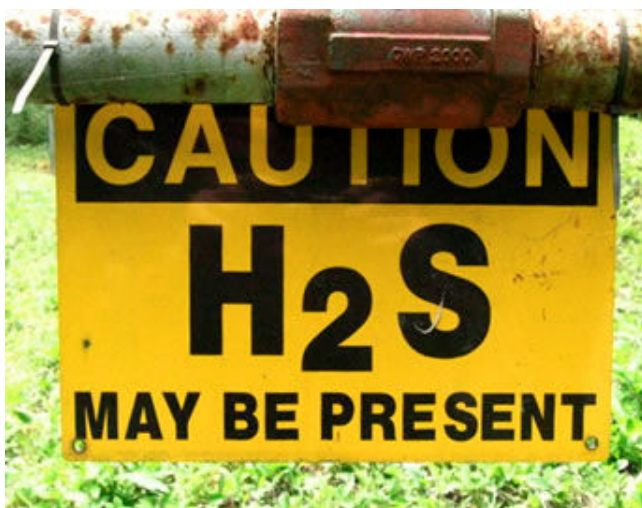
Photo 2. Hydrogen sulfide warning sign on the 47-039-02079 well in the Kanawha State Forest. Photo taken 29 August 2011.

presence of hydrogen sulfide gas, an extremely toxic gas in higher concentrations. The site had two tanks. The plastic condensate storage tank sat within secondary containment. This containment was in the process of being cut by an animal trail. The trap door was not locked. The other tank was steel, much larger, approximately 20 feet high, without secondary containment. A request for information about the purpose of this tank was unanswered by the Office of Oil and Gas.<sup>5</sup>

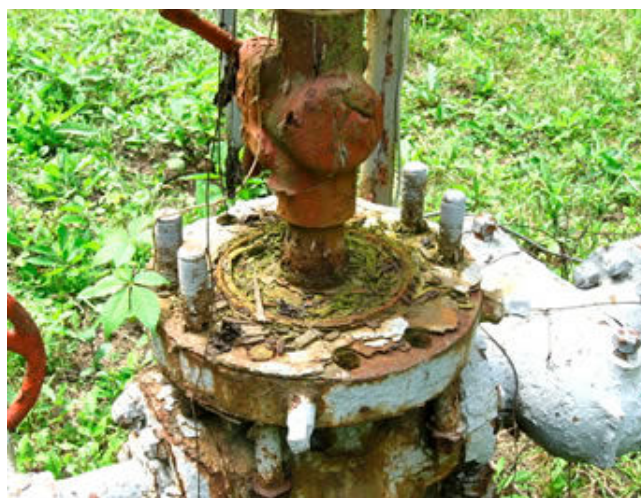
Photo 3. Severe corrosion at casing head and production pipe for the 47-039-02079 well in the Kanawha State Forest. Photo taken 29 August 2011.

One of the two wood sheds housing metering devices for the wells was beginning to collapse. Metal work on the Christmas trees for the wells was unpainted (deterioration at 47-039-2079 was pronounced). There was a strong hydrocarbon odor at the site. The complete absence of barrier or fencing for the wells/site was troubling, especially when hydrogen sulfide may be present, when attractive nuisances like the tall tank's ladder exist, and when possibly explosive gases are present.

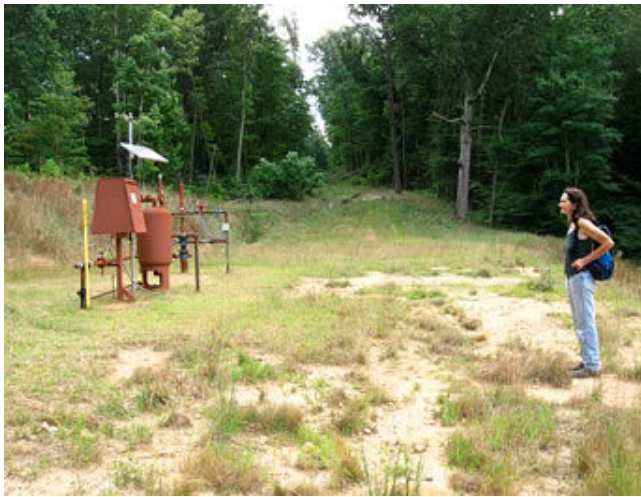
Photo 4. Well pad for 47-039-05772 which has a large expanse bare of vegetation between production equipment and edge of pad. This well site in the Kanawha State Forest had numerous signs of animal activity in the bare areas. Soil samples found elevated chloride. Photo taken 29 August 2011.

feet) that is almost entirely bare of vegetation and another smaller area on the fill slope below where there’s a seep. Because of the resident’s concern the state and operator took samples for laboratory tests. Appendix 1 discusses these test results.

We took samples, testing only for chloride, and found contamination on the pad soil surface (two locations with 40 and 46 ppm), slightly elevated concentration in the water sample from the seep (<29 ppm), and at background concentration for soil near the seep.

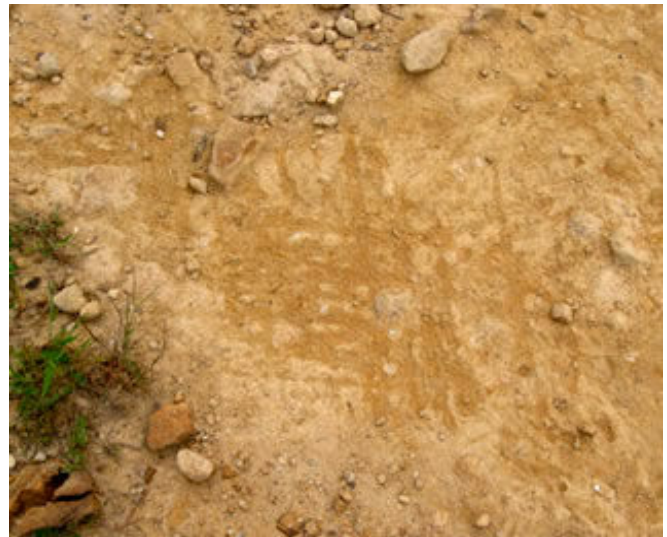
Photo 5. Turkeys have deeply scratched the soil on the pad at 47-039-05772 in the Kanawha State Forest. An inch or more of soil was removed around clumps of grass. Photo taken 29 August 2011.

Animal activity was evident in the bare area of the pad with portions of soil removed to the depth of an inch or more in places. Turkey claw scrapes were most common. We observed finches, singly or in small groups, ingesting the soil while we stood nearby.<sup>8</sup> The contamination may be from a single spill in the past, inappropriate management of flowback (see page 7 below for a description of

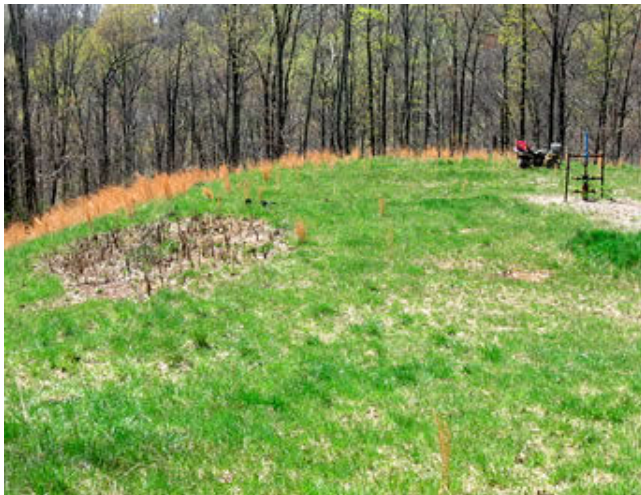
Photo 6. Well pad for 47-079-01288 vertical Marcellus well. Brown, barely vegetated area in left center of photo lies between large pieces of pit liner (pieces at one end are barely visible above brown area). Photo taken 14 April 2011.

Evidence of surface contamination at 47-079-01288 was a bare area (approximately 57 feet long) between two places where large pieces of pit liner were visible jutting up from the soil. Evidence of surface contamination at 47-079-01200 was a substantial area (approximately 84 feet long) of pit liner fragments and larger pieces where the surface owner had tilled for a garden on the pad.

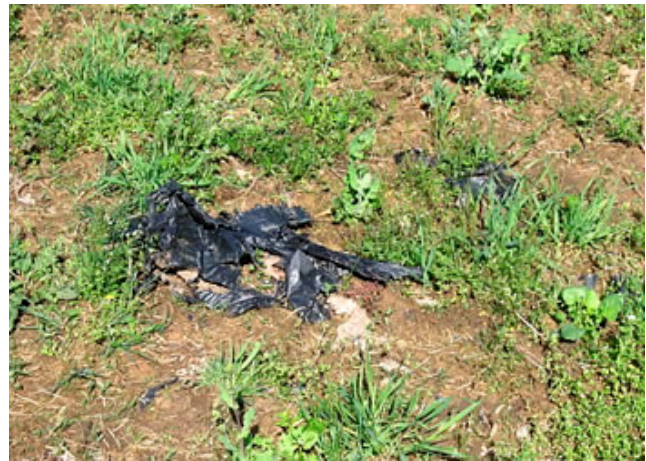
Photo 7. Pieces of pit liner lying in tilled area on the pad of 47-079-01200. Some pieces were firmly anchored in the ground, others were torn fragments lying loose on the surface. Photo taken 14 April 2011.

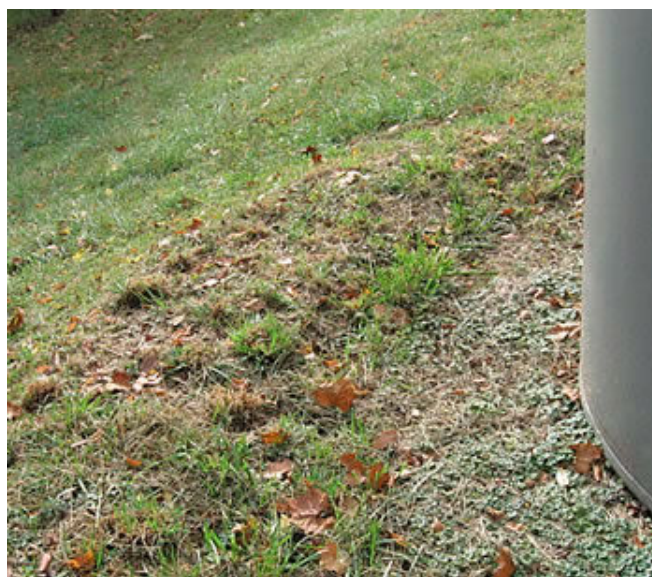
Photo 8. Inadequate secondary containment on river side of 47-079-00570 is no more than 8 inches high. The Pocatalico River is 47 feet downslope. Photo taken 16 October 2008.

The three wells are in Putnam county on or near the Pocatolico River. One of the wells, 47-079-00570, is a clear violation of state and federal (40CFR112) requirements because the secondary containment for its condensate storage tank is grossly inadequate and its proximity to the river. Complaints about this well, notice of the problem in our 2008 Gas Well Study given to the DEP, operator, state industry association, and notice to the EPA have shown no correction of the noncompliance.<sup>16</sup> (Other issues at this site include rusted metalwork and the API number lying on the ground.)

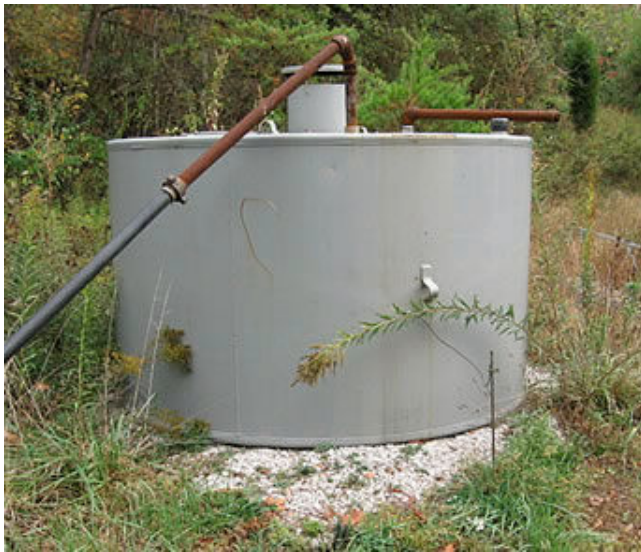
Photo 9. No secondary containment for the condensate storage tank exists at 47-079-00735. Photo taken 16 October 2008.

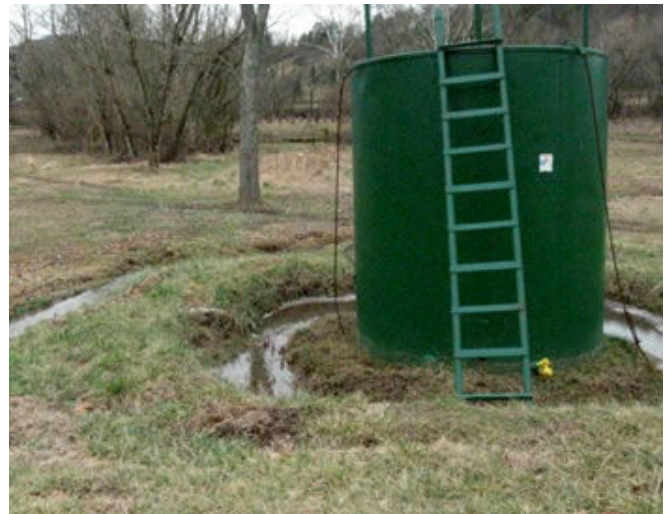
A locally operated well, 47-079-00583, is on a flood plain (high water the spring of 2011 came within feet of the tank's inadequate secondary containment). The tank is only feet away from a permanent stream flowing into the Pocatolico River. The 100 barrel tank has steel cables that are not tethered to the ground; nothing will prevent the tank's leaving its location in a serious flood.

Photo 10. Moat type secondary containment for the 100 barrel tank at 47-079-00583. The tank's tethers hang unattached to the ground. The containment is partially filled with water and the dike is severely eroded on the side facing the permanent stream (on the left in the photo). Photo taken 12 January 2009.

Secondary containment for a condensate storage tank normally (when done properly) consists of a substantial earth dike around the tank with a rainwater drain to allow the containment to be kept free of water. An older method of containment, moat-type, is sometimes found.<sup>17</sup> The containment is created by excavating a moat around the tank and using that dirt for a dike. The volume within the dike and moat is considered to be the containment area. In reality, because there is no rainwater drain, the moat is often filled with water, as observed at 47-079-00583 every time we have been to the site. Moat-type containment should be replaced by above-surface-level containment.

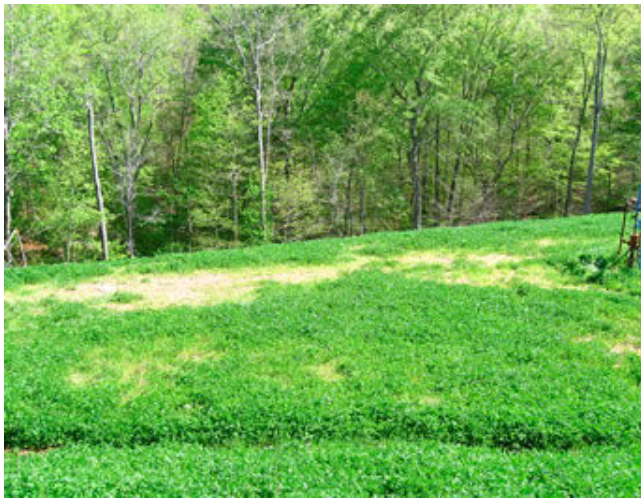
Photo 11. One of two large bare spots on the pad of 47-039-06155, a vertical Marcellus well. Pit liner was visible in the bare area here. Photo taken 30 April 2011.

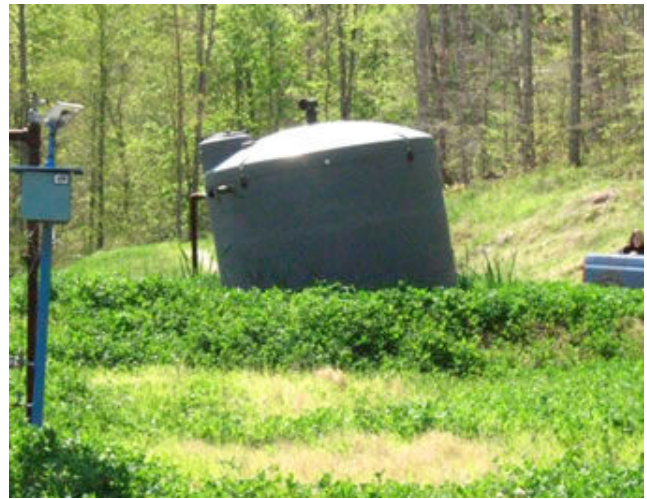
Photo 12. The large plastic condensate storage tank for 47-039-06155 floating within its water-filled secondary containment. Containment has a rainwater drain that appears to never have been used. Cattails are visible within the dike between the tank and the blue truck. Photo taken 30 April 2011.

Our preliminary site investigation found the following problems: the condensate storage tank was floating within its water-filled containment; large areas of the pad were bare of vegetation; pit liner was visible in one of these bare areas; beyond the pad at one end and along part of the fill slope were a large number of dead trees (dead trees followed a clearly visible drainage line down to the stream that flows below the pad).

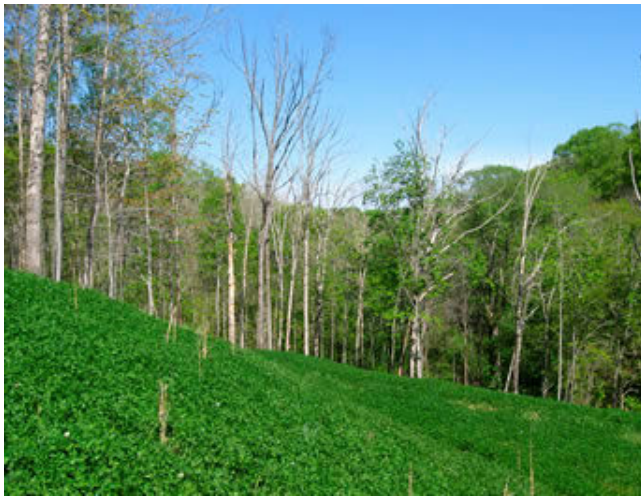
Photo 13. A large number of dead trees are beyond the end of the pad and alongside, going down the hillside to a stream at 47-039-06155. This is the area where, according to the surface owner, the operator let uncontrolled flowback from this vertical Marcellus well spray into the woods. Photo taken 30 April 2011.

Satellite imagery from 2007, before site construction, shows no dead trees. That for 2009 does, after the well was completed.

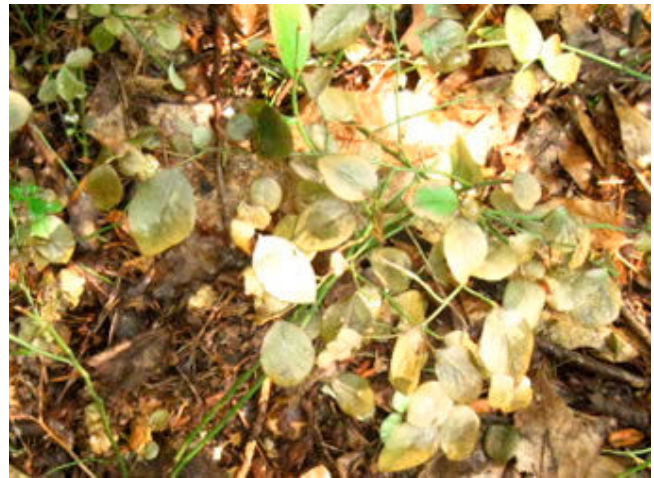
Photo 14. Vegetation showing severe chlorosis after application of fracture gel solution with 5,000 mg/l chloride. Application was made 8 days previous. Photo taken 6 August 2011.

Our application studies show that vegetation mortality can be expected from sprayed waste containing chloride.<sup>24</sup> A maximum chloride concentration of 3,000 mg/l (contrasting with the permit's 12,500 mg/l) must be enforced, with a load of 1,232 kg/ha.<sup>25</sup> Application cannot be done by spraying. Preliminary research in 2011 indicates that the presence of fracture gel in liquid waste enhances chloride's negative effects.<sup>26</sup> If fracture flowback or chemicals are in the waste, then the load must be lowered considerably. We believe land application of liquid pit waste and burial of solid waste on well sites under the current permit must be halted.

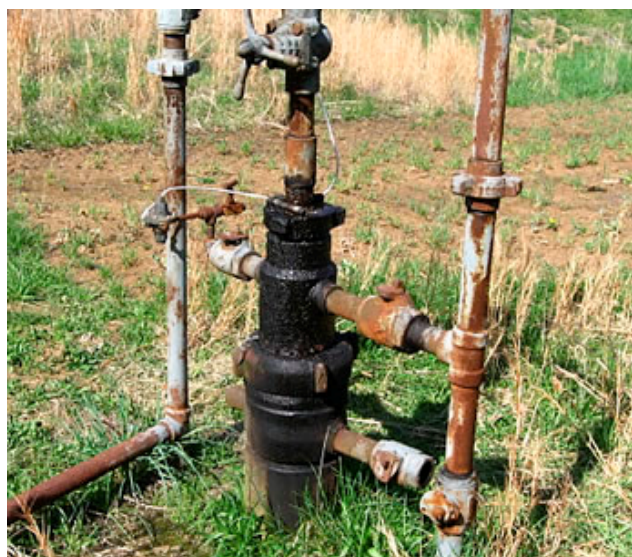
Photo 15. Wellhead for 47-079-01200 leaking oil-like substance. This leak has progressed from what we saw in 2008. Photo taken 14 April 2011.
