Gas Well Study, 2013

George Monk and Molly Schaffnit
March 2014

Gas Well Study is the examination of natural gas wells in West Virginia.

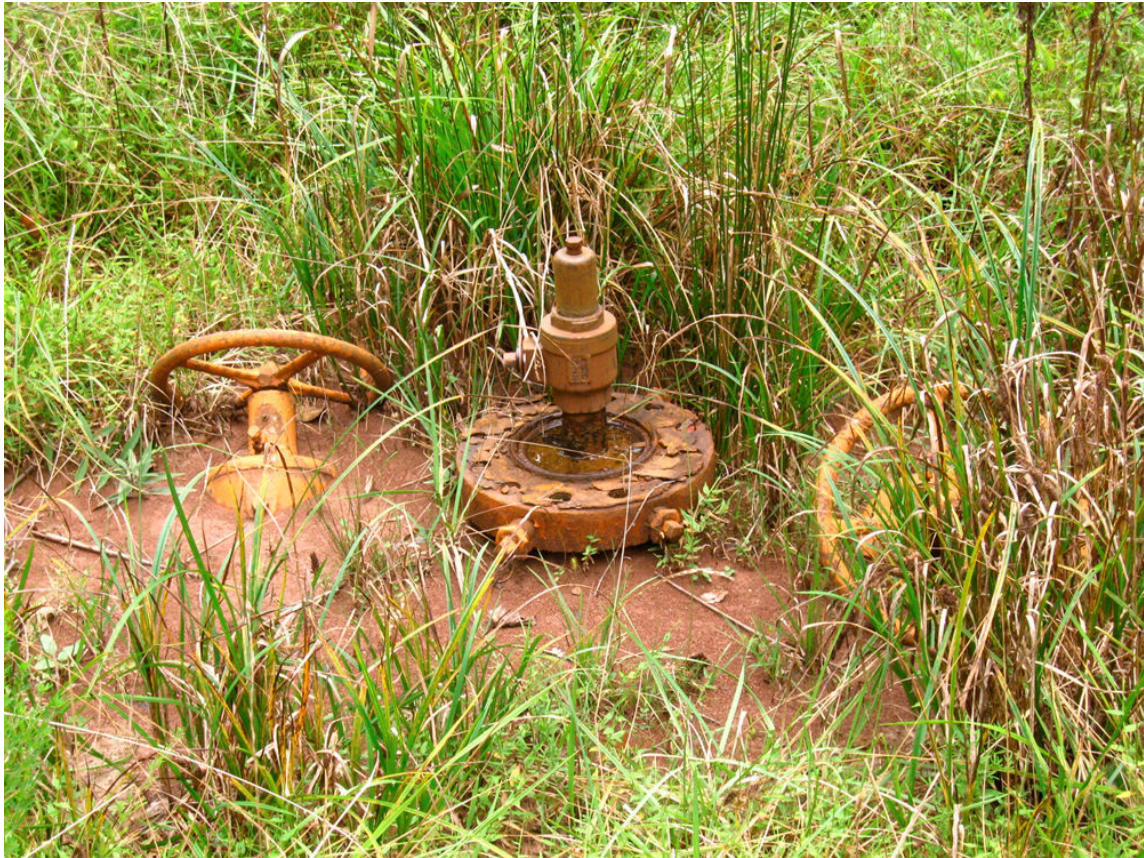
The wellhead for 47-079-00748, a producing well in Putnam county, West Virginia, has nearly been buried by sediment. The heavily corroded casing head has several small leaks. Photo taken on 16 September 2013.

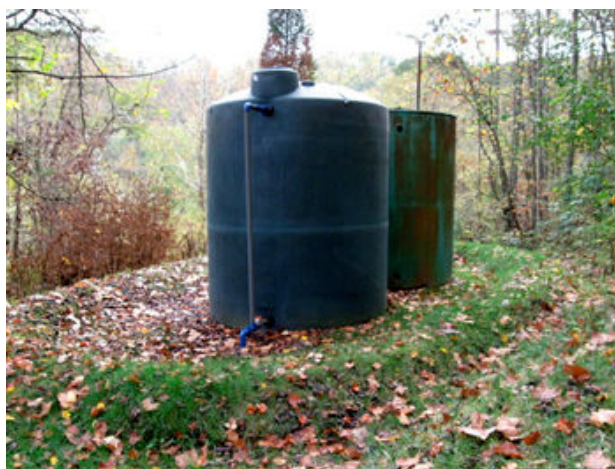
Photo 1. Tanks at 47-079-00746. The steel tank behind the large plastic tank has large holes. Containment dike has eroded on river side (left in photo) so that containment no longer is adequate. Photo taken on 16 October 2008.

47-079-00746 is a well we previously visited in 2008/2009 and described in *Gas Well Study, 2009*.² An API number is present at this older well site. A large stack of rusty pipe lies next to the well head. There are two large 100 barrel tanks; the steel tank has holes and is not being used. Secondary containment is present around both tanks but the earth dike is so eroded at points that containment is not adequate.

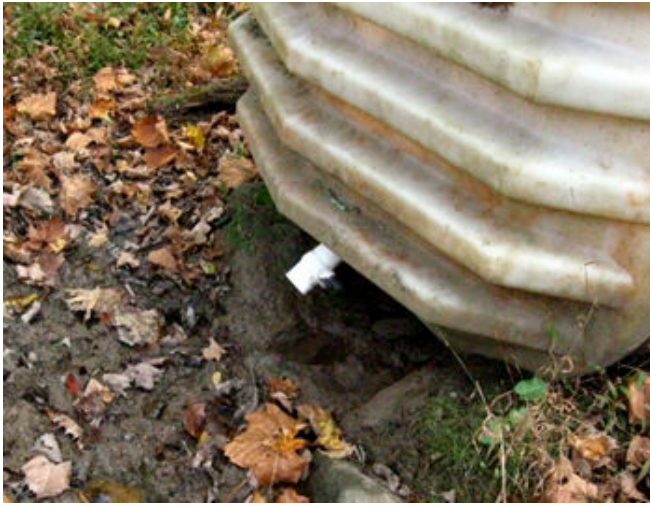
47-079-00615 is an abandoned well. It was not producing when we visited in 2012, gas flow was audible in April 2013. There is no API number on the well and the tank has no secondary containment. During April's visit we tested soil and water samples at the site. We tested a water puddle away from the tank for chloride and took a soil sample from below the tank's leaking lower valve. The soil sample showed chloride at >641 ppm (the upper limit of our test method); the water sample showed no chloride. Chloride normally does not persist in soil and concentrations in soil are normally close to 0 ppm. We will return to this well in our response to the Office's inspection report (page 13).

Photo 2. When we revisited 47-079-00615 in April 2013 we found the well producing. Fluid in the tank was slowly leaking from the valve at the bottom of the tank. The soil sample taken here had chloride at more than 641 ppm (the upper limit of our test method). Photo taken on 12 October 2012.

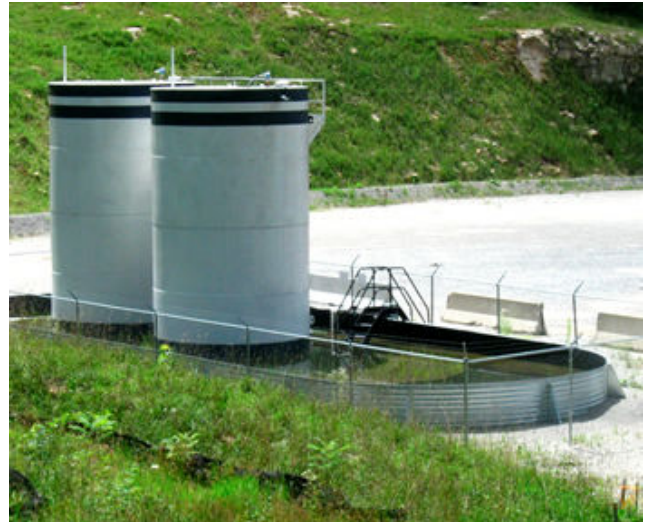
In 2012 we noted poor drainage control and use of the site access road as drainage from the site. We noted rills in the access roadway gravel in 2013. A new gate was found at the site entrance. Secondary containment was present for the large storage tanks, though it was partially filled with water. We were told that standing water in the containment was not uncommon.

Photo 3. These two large storage tanks are at the edge of the Tall Trees pad in Upshur county (47-097-03707 and 47-097-03708 horizontal Marcellus wells). The containment would be adequate if it were not more than half full with standing water. Photo taken on 14 July 2013.

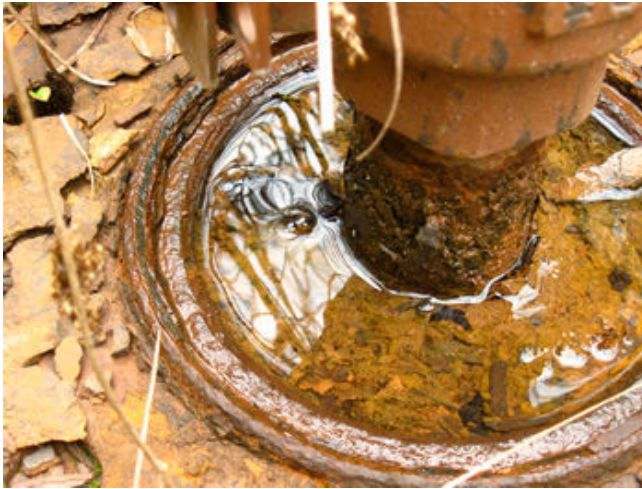
Photo 4. There are several small leaks on the heavily corroded casing head for 47-079-00748. Standing water was bubbling. Photo taken on 16 September 2013.

47-079-00748 is a poorly maintained older well site with a number of problems located northwest of wells near Camp Virgil Tate we looked at in 2012. The wellhead is in a low excavated area on the pad which we call the “basin.” Because of severe site erosion the wellhead is almost completely buried in silt. The well’s casing head had several leaks.

The API number is present nearby but just showed the last three digits. There is an extremely tall separator (similar to that noted at a Kanawha State Forest site in 2011).⁶ The 100 barrel steel tank is in a heavily overgrown area. A dike is present but it wasn’t possible to determine if it is adequate.

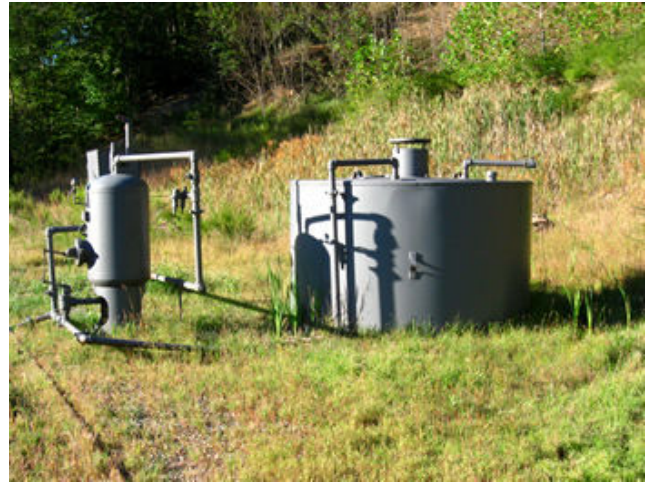
Photo 5. Tank and separator for 47-079-01324. The tank does not have required secondary containment. Photo taken on 23 September 2013.

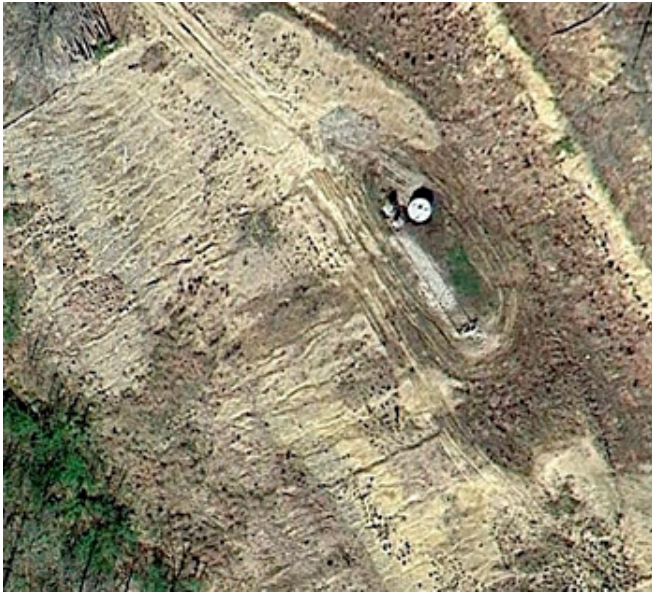
Photo 6. 26 March 2012 Google Earth image of 47-079-01324 in the Amherst Plymouth WMA. The large severely eroded fill slope takes up most of the left portion of the image. Google Earth imagery like this shows lack of secondary containment for tanks at wells in the WMA. Some sites like this have problems with slips and/or severe erosion.

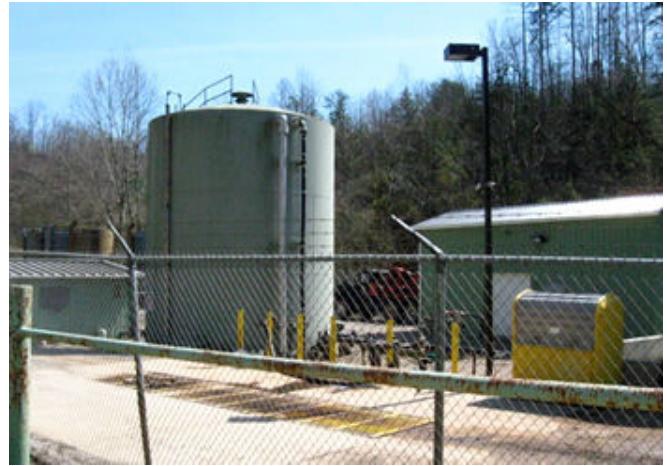
The site has three tanks. One large 57,000 gallon tank has no visible secondary containment. Two much smaller steel tanks are within cement secondary containment next to a cement (but without berm/curb) unloading area. Drains to a sump seemed to be present. The large tank appears to be in violation of state and federal law but when asked about it a representative of the Office of Oil and Gas stated it didn't need secondary containment, the tank was double walled, with an inner and outer wall providing containment.⁷ Examination of the large

Photo 7. The large tank at UIC class 2 well 47-039-02210 next to Tupper's Creek holds 57,000 gallons. It has a flammability warning posted. There is no visible secondary containment. The unloading pad is in the foreground. The yellow grid appears to be grates covering a sump. Photo taken on 6 April 2013.

paper file in the Office for the well found, in documents related to the sale of the well to the current operator in 2008, mention of the "57,000 gallon ground, double-walled tank" but nothing about the tank having two walls. Industry's *double walled* nomenclature can mean a tank with a wall twice as thick as standard. Such a tank would require secondary containment.⁸ (Further discussion about the issue of double walled tanks appears on page 15.)

double walled, i.e., had extra thick walls to resist corrosion or vandalism. 35CSR1.7 has no mention of a double walled tank as meeting spill prevention requirements for adequate secondary containment.

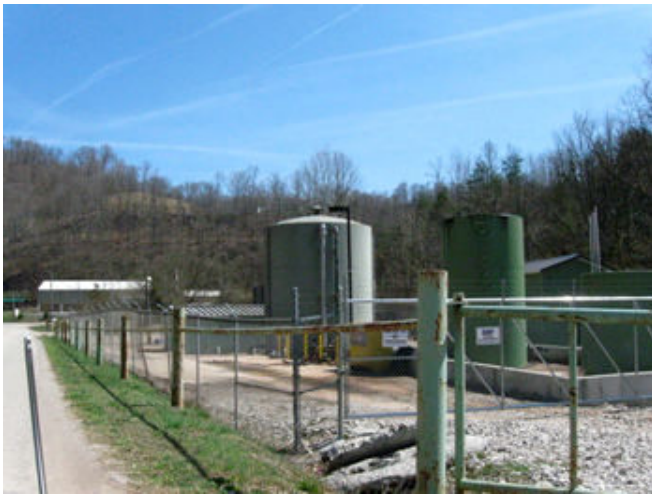
Photo 8. The UIC class 2 facility next to Tupper's Creek (47-0039-02210). The containment with two smaller tanks is in the right foreground. In the center of the photo is the 57,000 gallon tank. Utility buildings and the injection well are behind the large tank. The site is well secured with fencing and locked entrance gates. Photo taken on 6 April 2013.

When we visited in April 2013 there was a very strong and acrid condensate odor (the large tank is labeled with a warning about flammability). There is a residence across the street from the UIC class 2 site and a church a short distance away. Documents in the UIC class 2 well's paper file included a complaint of medical harm made by a local resident. The well's UIC permit (condition 21 of the 2012 permit) requires a "vapor recovery system" on all tanks to prevent odors. We couldn't find documentation within the file showing that a vapor recovery system is actually present on the tanks.

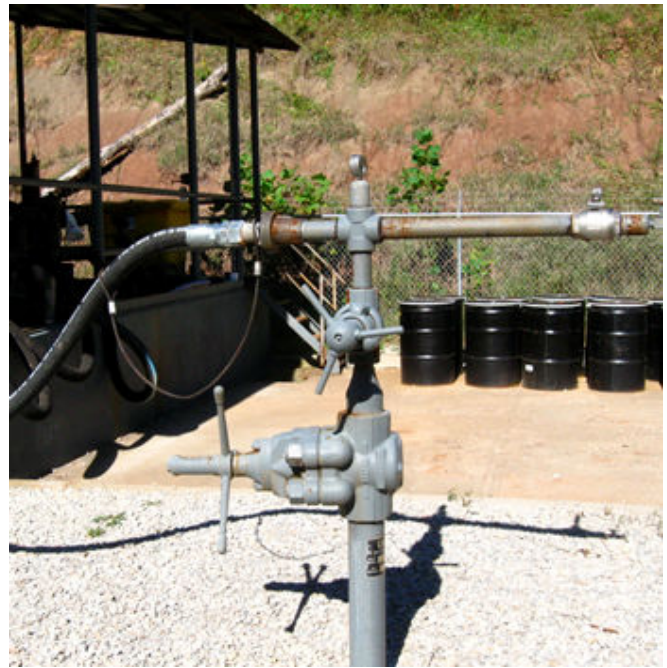
Photo 9. The UIC class 2 wellhead at 47-079-01452. The black pipe to the left carries fluid to the well. There's a pressure gauge on top of the wellhead. The annulus pressure gauge is hidden by the well in this photo. The cement unloading pad is visible behind the wellhead. The pad is sloped toward the work area and toward the sump under the steps behind the wellhead. Photo taken on 6 April 2013.

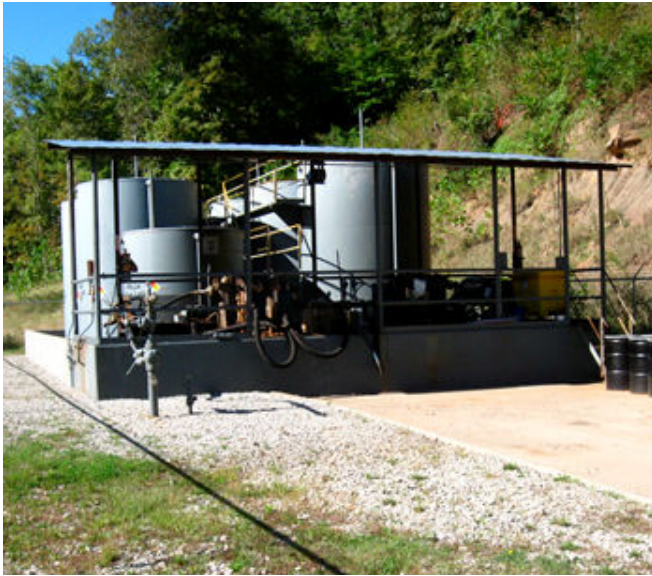
Photo 11. The UIC class 2 well facility in the Amherst Plymouth WMA (47-079-01452). The cement unloading area (with curb) is in the right foreground. The work area with pump and filters is in the middle ground. A steel grate covers the whole work area platform so that any spilled fluids go into a sump. The tank battery within a cement lined secondary containment is visible in the background. Photo taken on 6 April 2013.

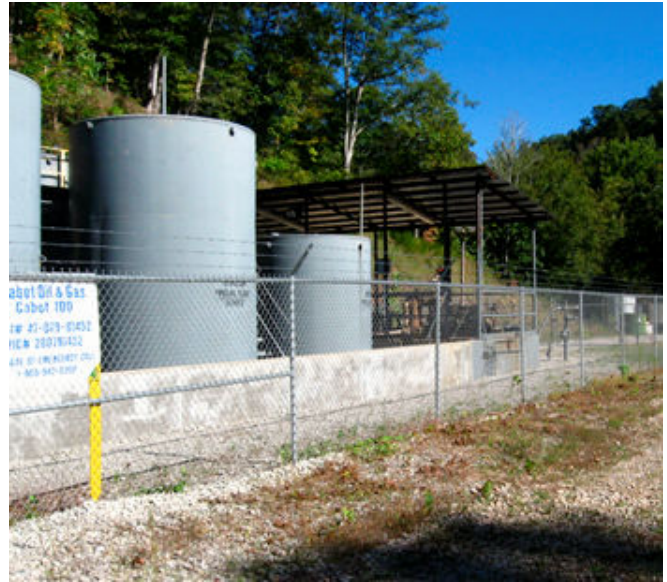
Photo 12. The tank battery at the UIC class 2 facility in the Amherst Plymouth WMA (47-079-01452). The 6 large tanks sit within cement lined secondary containment. The work area is covered with a metal roof toward the middle right of the photo. Photo taken on 6 April 2013.

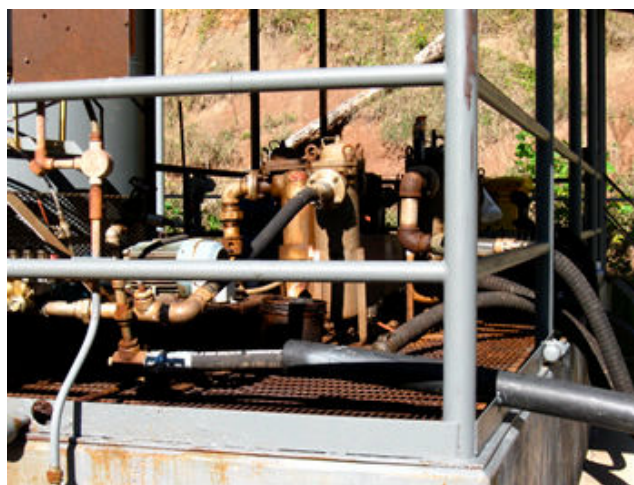
Photo 15. The work platform at the UIC class 2 facility in the Amherst Plymouth WMA (47-079-01452). The cement walled platform is covered with a grate so spilled fluids go into a sump. The black pipe in the foreground goes to the injection wellhead. Photo taken on 6 April 2013.

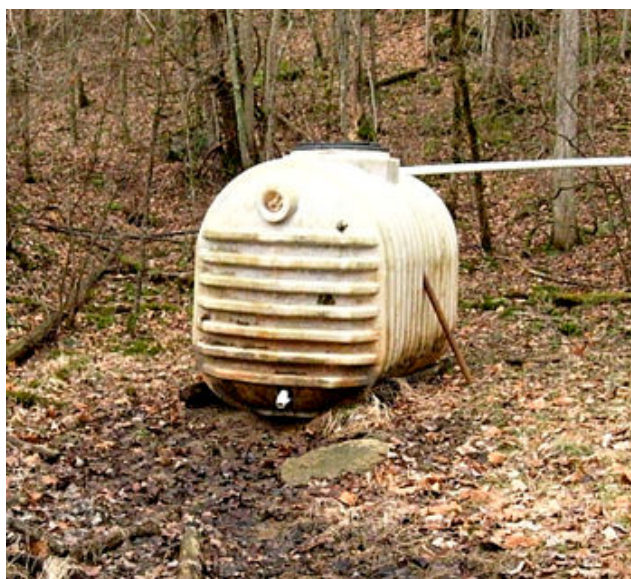
Photo 17. This is what the inspector in the Office's report wrote about 47-079-00615: "double walled tank looked o.k." The tank is leaking at the valve at the bottom and requires replacement or repair. The single wall tank requires secondary containment. Photo taken on 26 February 2009.

The plastic tanks on the Cranberry pipeline and at 47-079-00615 do not meet the law's requirements. The plastic tank at 47-079-00615 has open inlet and outlet holes near the top, which allow inspection of the interior of the tank. A revisit of the site in April 2013 found fluid dripping from the tank's bottom valve. A test for chloride in the soil found >641 ppm (above the upper limit of our test).

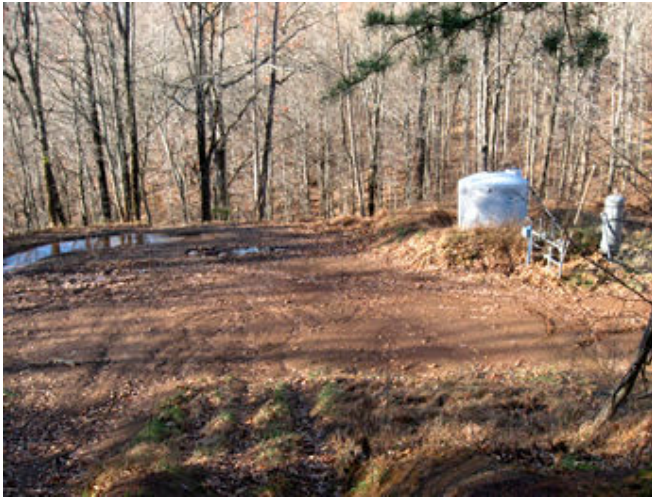
Photo 18. This provides a view of the mostly bare pad for 47-079-00702. The bare pad extends an equal distance to the left of the photo. Vegetation on the pad surrounds the well equipment only. The inspector wrote of this site in the Office's report: "site looked good with grass/vegetation growing." Photo taken on 18 November 2013.

The Office inspected the site on 8 July, we revisited in November. The inspector found: "double walled tank with tank dike," and "site looked good with grass/vegetation growing." Our visit in November found the well access road had deteriorated since our 2012 visit. The pad is about 80% bare of any vegetation. The large plastic tank is sitting within secondary containment but there is no rainwater drain as required in 35CSR1.7.

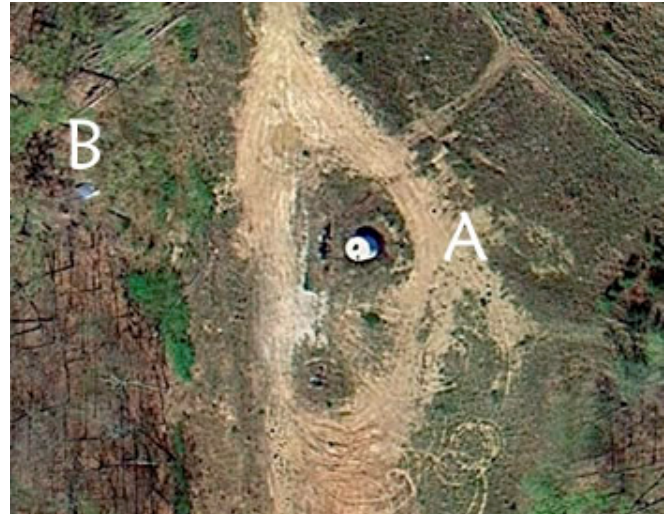
Photo 19. This is a 26 March 2012 Google Earth view of the pad for 47-079-01314 which shows vegetation coverage problems we found in 2012 and earlier visits. The letter A indicates the approximate location where samples showed high chloride in soil and surface water. The letter B shows the location of the blue portolet which has been pushed into the undergrowth away from the pad.

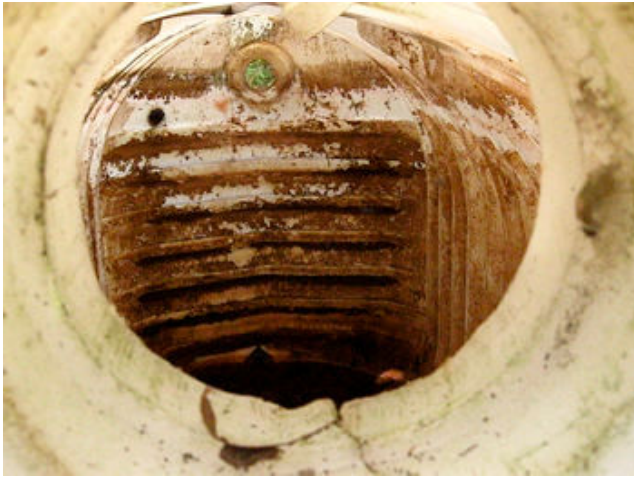
Photo 20. This is a view inside the tank at 47-079-00615 which the Office's inspector called "double walled." The tanks appears to be a reused septic tank and has only one wall. Photo taken on 12 October 2012.

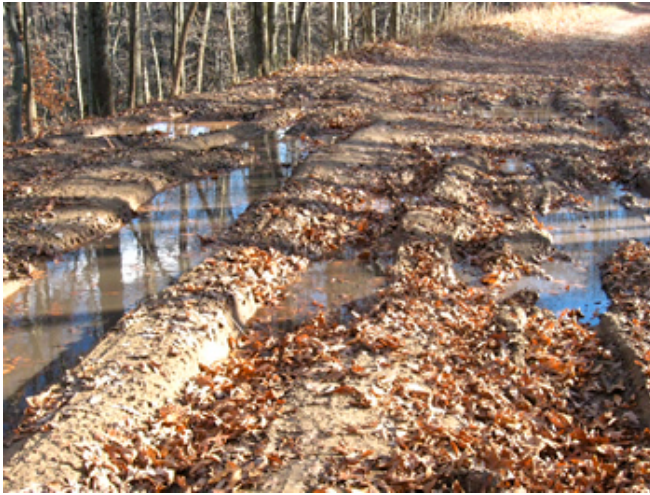
Photo 21. This photo shows the main well access road for a number of gas wells (what we call the Long Road). This spot is just north of 47-079-00702 and is deeply rutted. The Office's report found no issues with the road – "drains in good condition." Photo taken on 18 November 2013.

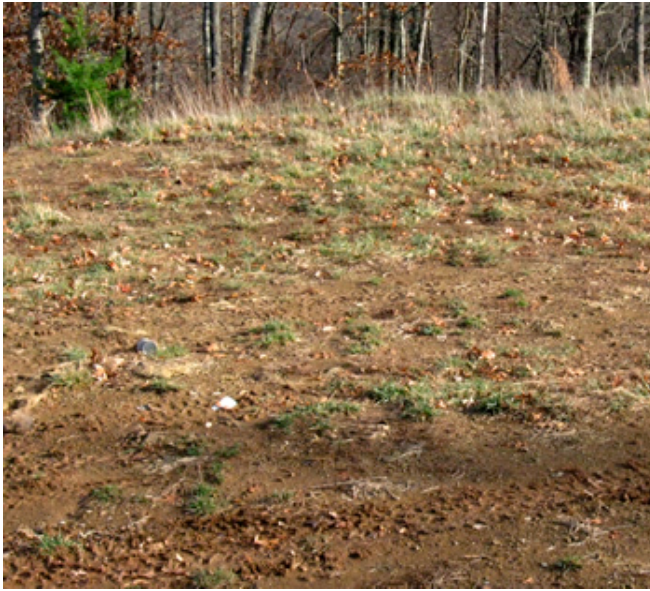
Photo 22. This is the portion of the pad for 47-079-01314 where we found contaminated soil at the former location of the pits. The vegetation is sparse here as it is over most of the pad. The Office's inspector in their report wrote about this well: "area has good vegetation." Photo taken on 18 November 2013.

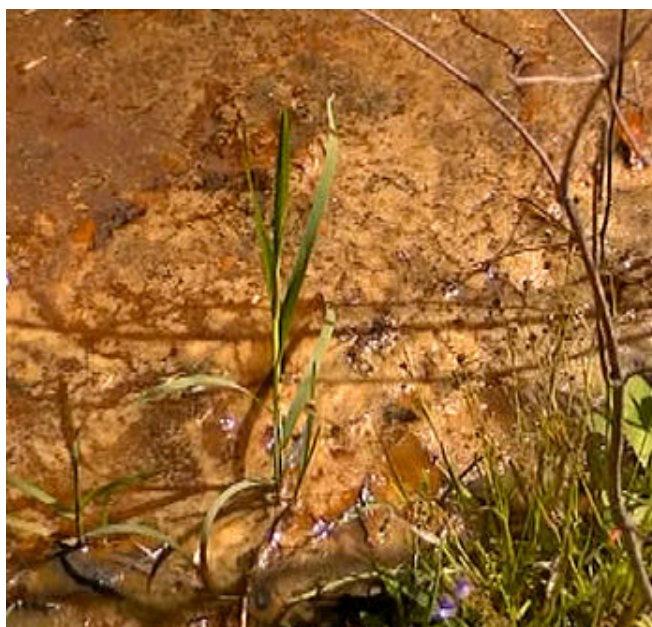
Photo 23. Appearance of stream running alongside pits and downstream at 47-019-00460’s facility. Stream before reaching facility is clear and has low chloride. In this part of the stream a hydrocarbon scum rests on the surface of the water and chloride has tested as high as 301 ppm. Still from video shot by Beth Little of the West Virginia chapter of the Sierra Club in May 2013.
