Gas Well Study, 2008

Observations from Visiting
Gas Wells Operated by One Company
in Putnam and Kanawha Counties, West Virginia

George Monk and Molly Schaffnit
February 2009

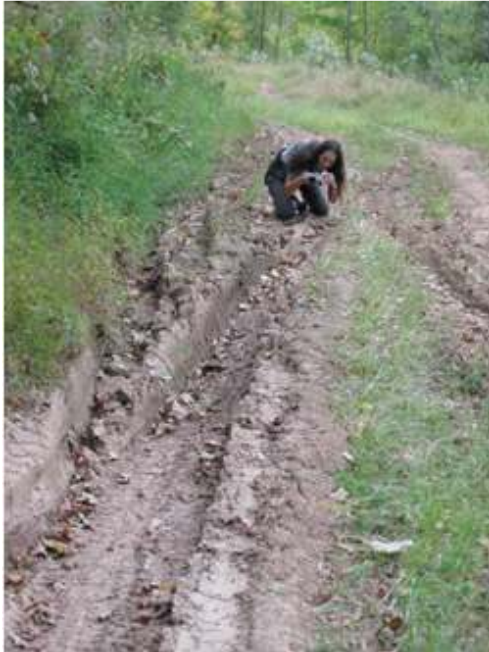
47-079-01178

This road had serious rutting caused by inadequate drainage. The road itself was a challenge for the company to create, going down steep grades into a hollow.

The problem here was caused by a slip narrowing the road width so that vehicles had to use the side ditch as roadbed.

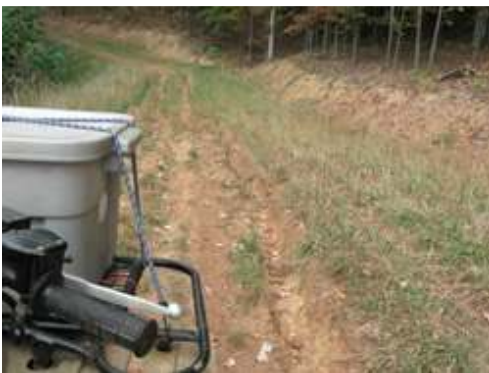
47-079-01228

A newer well with a deeply rutted access road from a main access road that serves a number of wells. This road had been "daylighted" but still had severe problems.

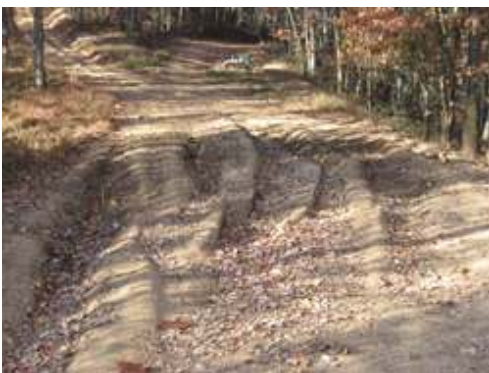
Just north of 47-079-00702

This access road serves a number of well sites and is in serious need of repair and maintenance. Drainage control in some spots is nonexistent.

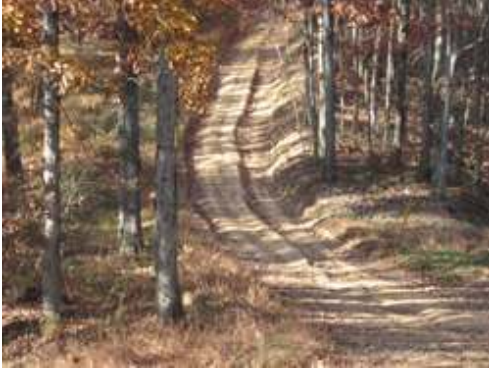
Just north of 47-079-00702

Another photo of the same road. This road is several miles in length and like this in long stretches.

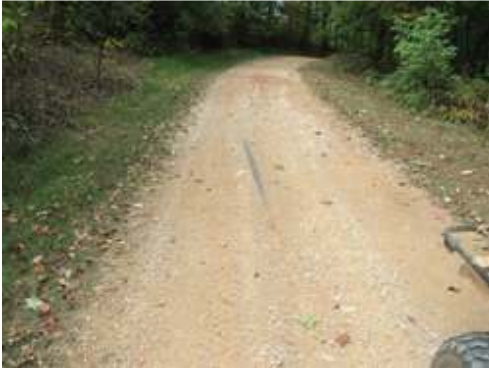
On main access road before 47-079-01299 access road, a 6-inch pipeline is exposed in two widely separated areas. This is the spot closer to 47-079-01299.⁵

⁵ Current rules (35CSR4.16.7.c.2) require pipeline be under at least 18 inch cover, 6 inch if solid rock doesn't permit deeper burial, but existing pipelines were grandfathered in 1983 and perhaps this one dates before then. Even so, it looks dangerous and probably is dangerous.

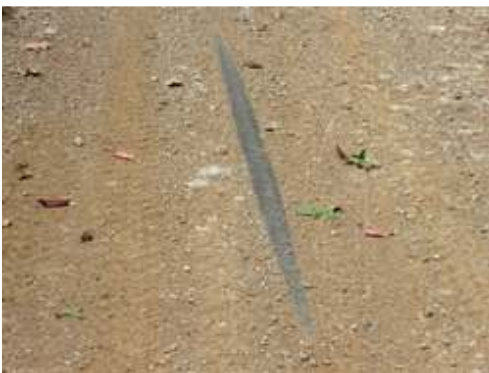
A close-up of the exposed 6-inch pipeline.

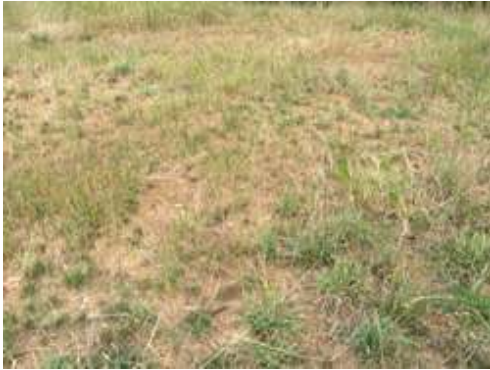
47-079-01299

Sparsely vegetated pad of a newer well. Older wells had, generally, just as much a problem if not more.

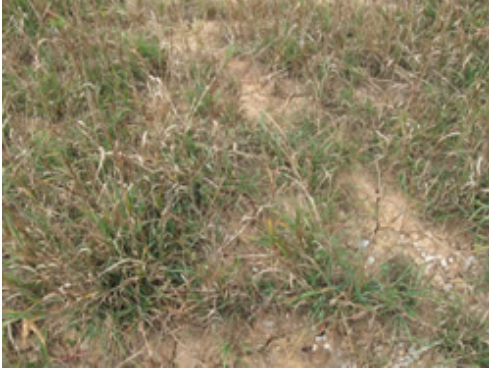
47-079-01288

Another sparsely vegetated pad.

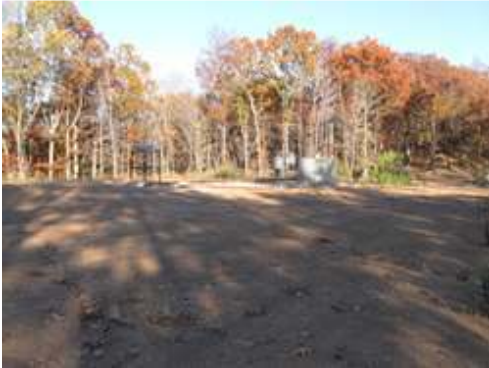
No API 3

This site hadn't been seeded even though it was early November.

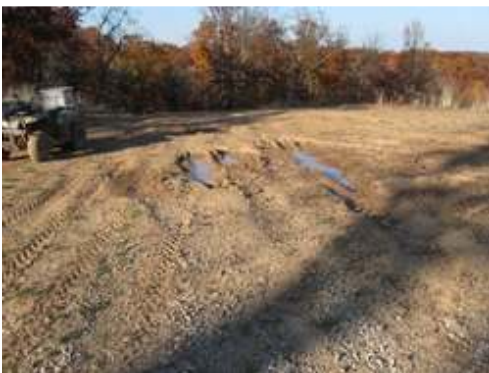
No API 1

An almost bare well pad with rutting. It had rained several weeks previously.

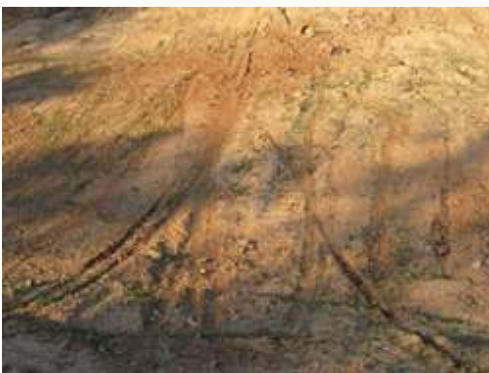
No API 4

Dirtbike tracks on cut slope above pad which had recently been seeded. The site had no gate or fence.

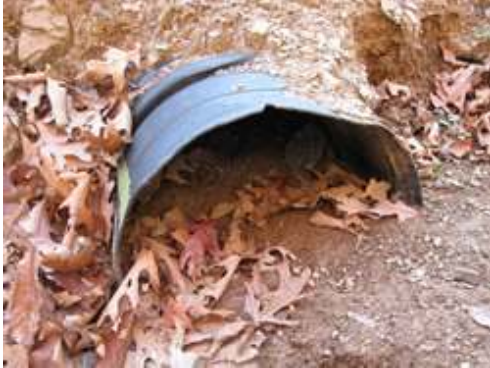
No API 3

This is the inlet end. No sedimentation control at the outlet end.

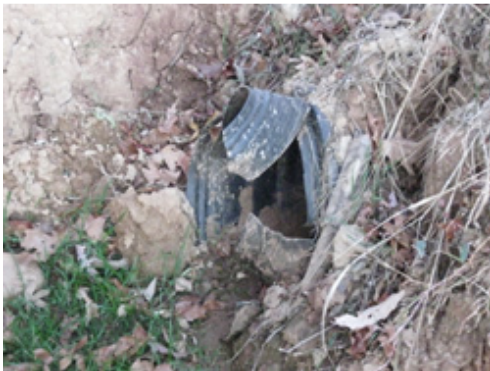
No API 4

Partially wrecked culvert inlet.

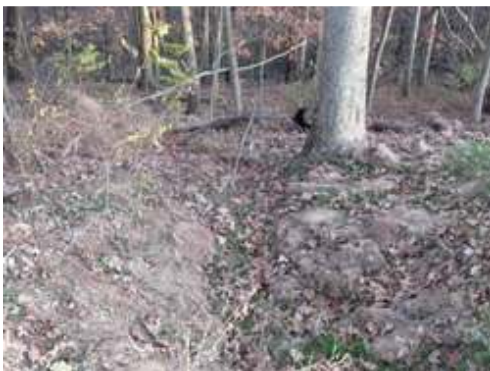
No API 4

Outlet of culvert in previous photo. No sedimentation control until vegetation is established.

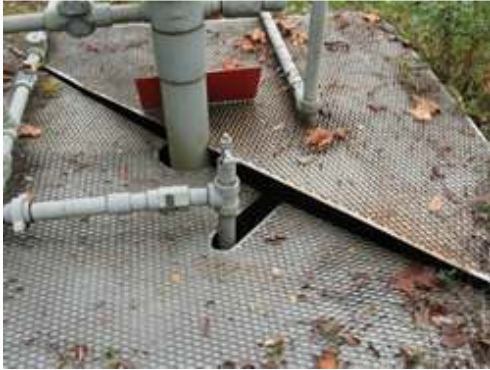
47-079-00735

This well had steel plates over a void at the wellhead. The void should be filled with rock to the ground surface for two reasons. First, the plates are unstable and have a gap. Second, the void creates a breeding place for mosquitoes.

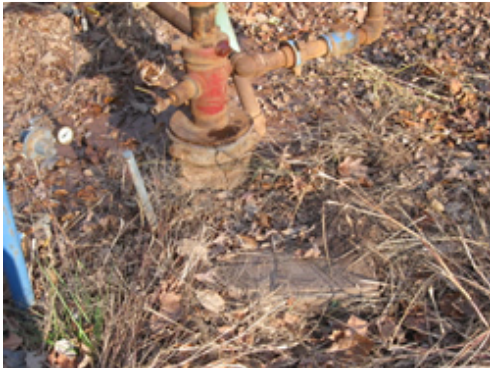
47-079-00702

Low spot at wellhead should be brought level to the surface to prevent ponding and old timbers should be removed.

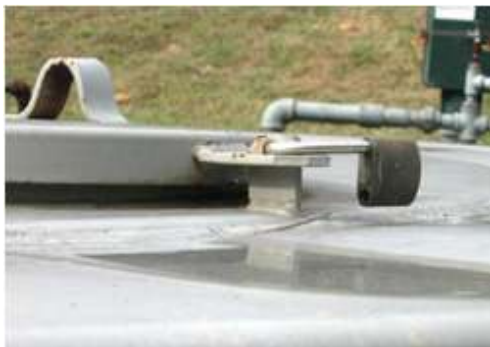
47-079-00570

Open lock at trapdoor to tank.

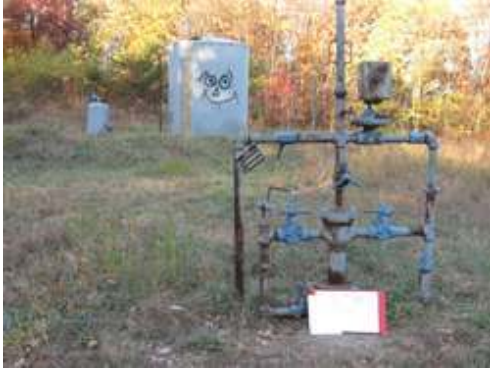
47-079-1155

Tank in background has a dike without rainwater drain. Additionally, the tank has no trapdoor.

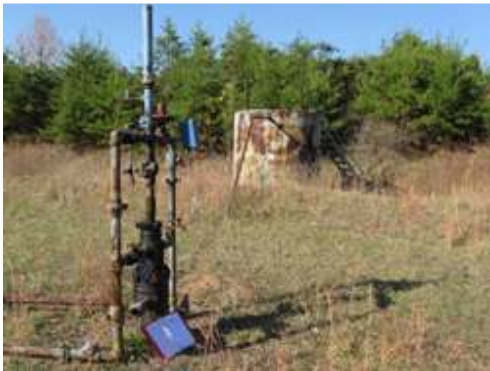
47-079-01200

Metal at this well is in serious need of paint. Would the company want to use a photograph of a well looking like this on its website or in its annual report?

The tank has an impressive dike but no rainwater drain that we could see.

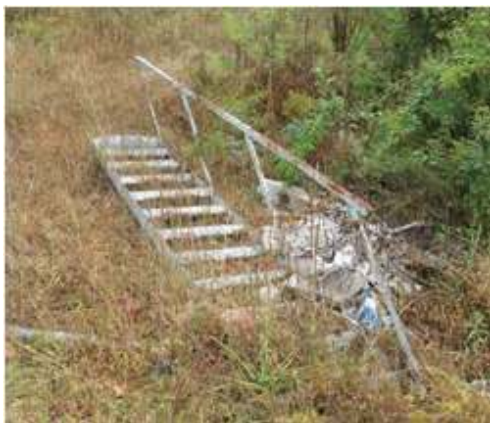
47-079-0735

Old steps from former tank and pipe.

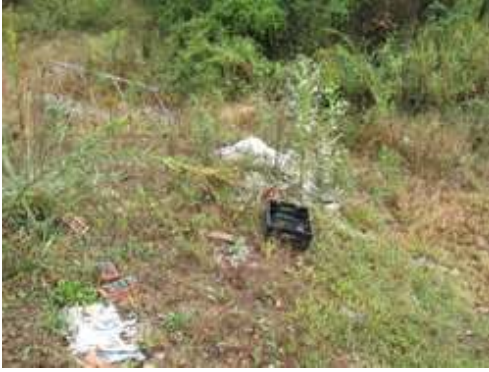
47-079-0735

The trash at this site was a mixed lot and it was impossible to tell what was the company's and what had been left by others.

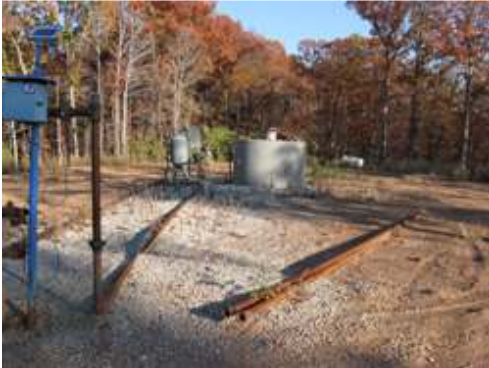
No API 3

The tank in the background is without a dike.

The scrap pipe should be hauled away.

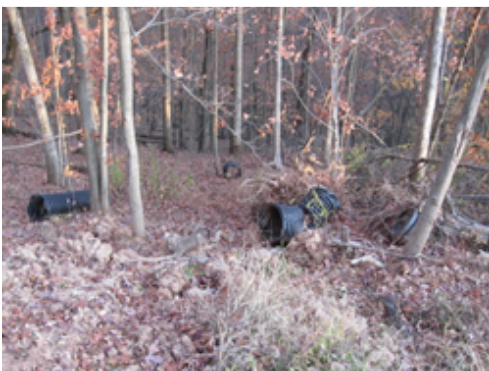
No API 4

Scrap plastic culvert tossed over hillside.

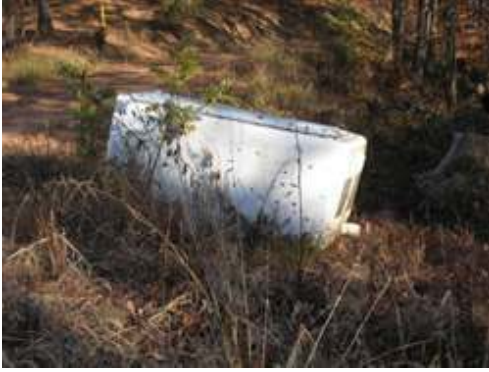
No API 3

Tipped over portolet which looks like it's been left as trash.

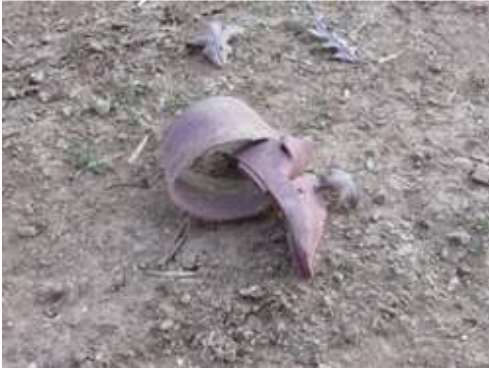
No API 4

Scrap plastic pipe thread protector (?) lying on recently seeded well pad.

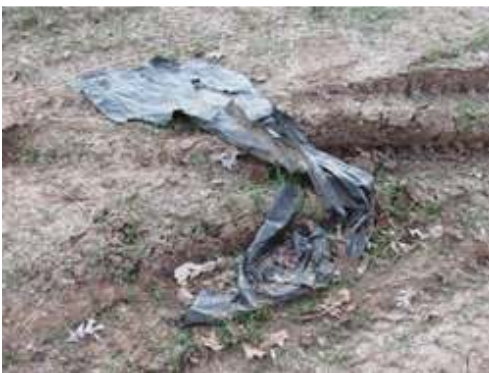
No API 4

We've seen pieces of black plastic on a number of recently reclaimed well sites, though usually they aren't as exposed as this.

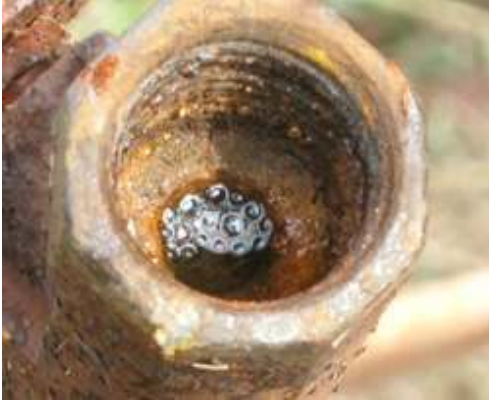
47-079-00570

A leaking valve in the Christmas tree at the wellhead. It had rained the night before and the leaking gas was bubbling the water.

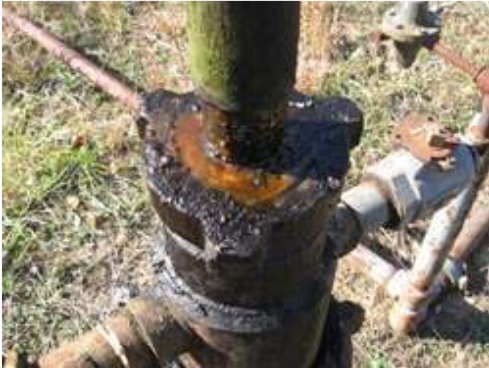
47-079-01200

Unknown substance leaking at well head.

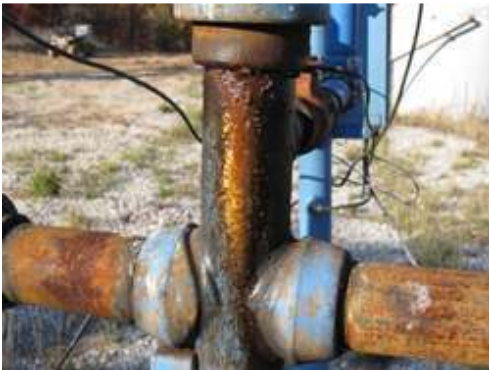
No API 1

This joint at the Christmas tree seems to be leaking unknown matter.

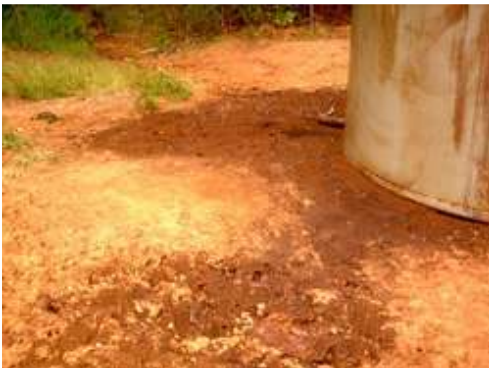
47-039-02026

A complaint was called to the Office of Oil and Gas on 8 September 2008 by George for 47-039-02026. The company built a dike around the tank a week after the complaint.

Tank that had overflowed the previous winter. This and the next photo were taken in early September 2008.

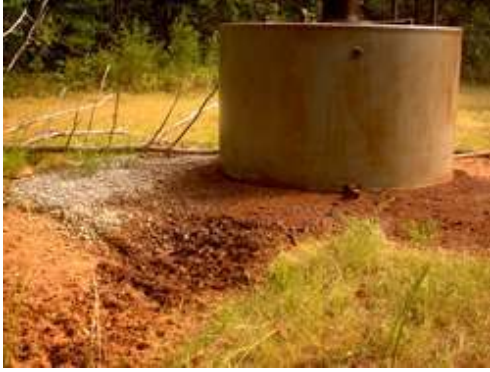
47-039-02026

The oil had gone down a ditch over the hillside.

The tank now has a dike.

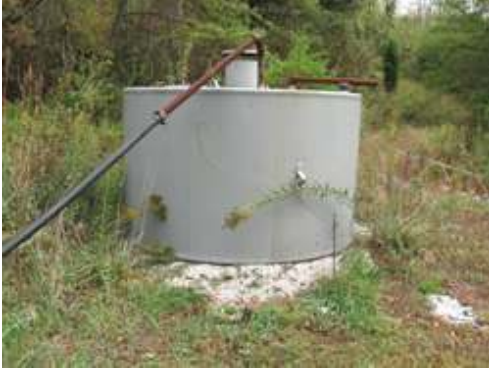
47-079-0735

Two sites without secondary containment were close to the Pocatamico River -- 47-079-00570 and 47-079-00735. The former, actually on the bank of the river, is covered by federal SPCC regulations.¹⁰ The latter site needs to be closely examined by an inspector to see if it doesn't also fall within federal requirements.

50-barrel tank without a dike.

This site is close to the Pocatalico River.

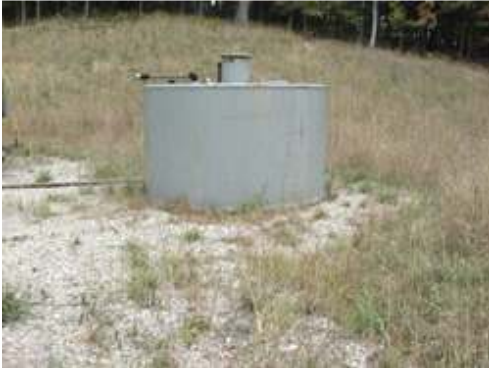
47-079-01288

50-barrel tank without a dike.

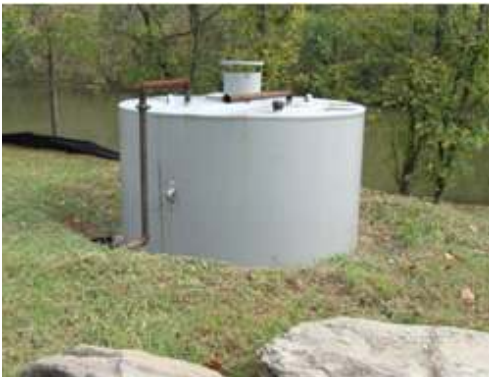
47-079-00570

This site is on the Pocatalico River (which is visible in the background). The remains of a dike surround the tank but the dike is wholly inadequate. This is a federal SPCC violation.

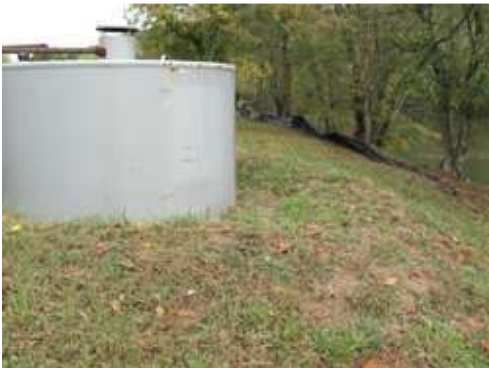
47-079-00570

View of the tank's dike on the river side, which is the dike's lowest point.

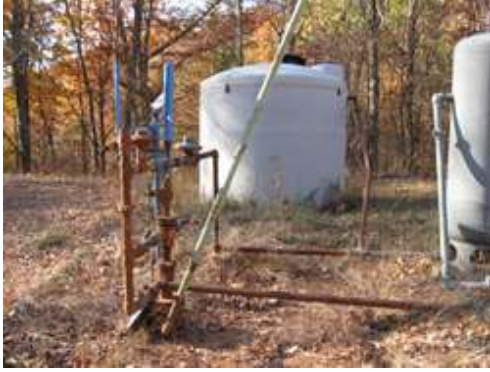
47-079-00702

Large plastic tank without a dike.

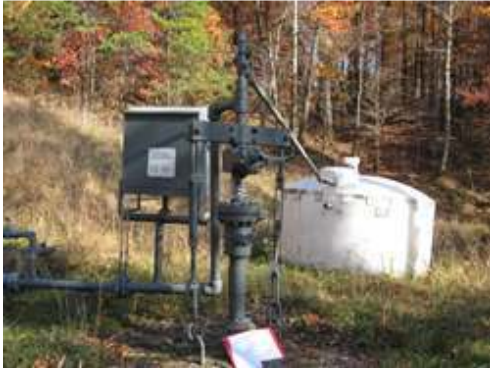
47-079-00274

This is a storage well site with a, what looks to be 50-barrel, plastic tank.

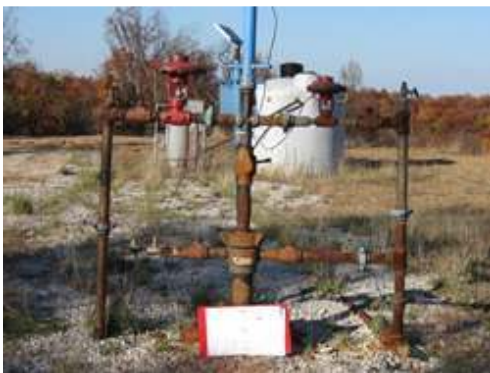
No API 1

Large plastic tank without a dike.

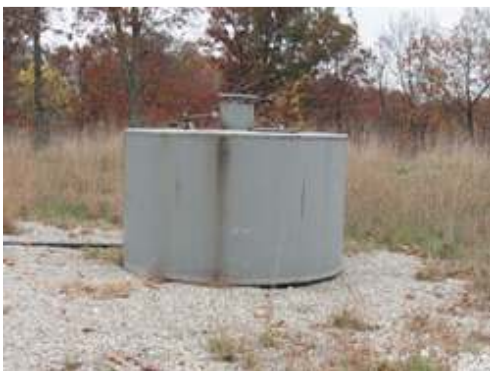
47-039-05714

Another 50-barrel steel tank without a dike.
