Gas Well Study, 2010

Reexamination of Some of the Wells Operated by One Company
Visited in 2008

George Monk and Molly Schaffnit
February 2011

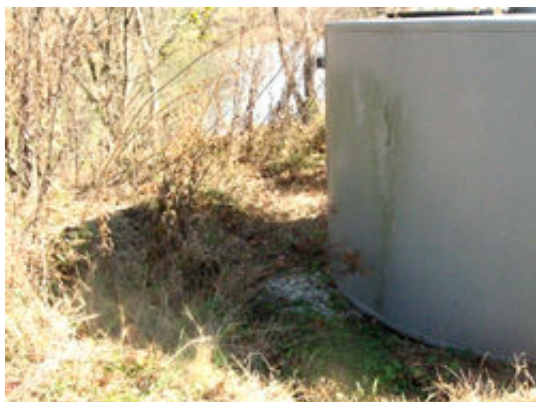
Returning to the sites in 2010 we saw an important improvement in compliance at almost all sites. Only one site had no containment (47-079-00735) and another had a grossly inadequate containment dike (47-079-00570). This latter site falls under federal purview because of its location above the Pocatalico River, a major tributary of a river used for interstate commerce.

We had brought 47-079-00570's non-compliance to the notice of the state's Office of Oil and Gas and to the EPA in 2009. Our visit in late 2010 showed no change at all from what we first saw in 2008, which is troubling.⁸

The site for 47-079-00570 was partially overgrown so the inadequacy of the tank's dike was hard to photograph. The dike is 8 inches high at its lowest point which is on the river side. Just 47 feet down a steep slope from the tank is the Pocatalico River.

While the operator has greatly improved their compliance in the issue of secondary containment, one serious lapse (47-079-00570) needs to be immediately corrected.

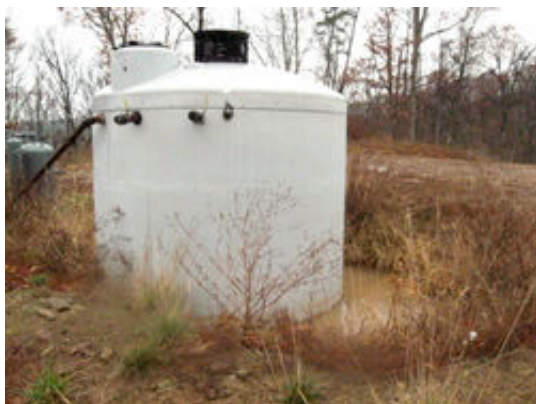
Two of the containment dikes seen in 2010 were without the required rainwater drain, and that for 47-079-01314 was partially filled with water.

The plastic storage tank for 47-079-01314 had containment without a rainwater drain. The well is located near a spring and the water in the dike may be spring-fed. Standing water in containment area prohibits full containment of a tank's contents in the event of a leak.

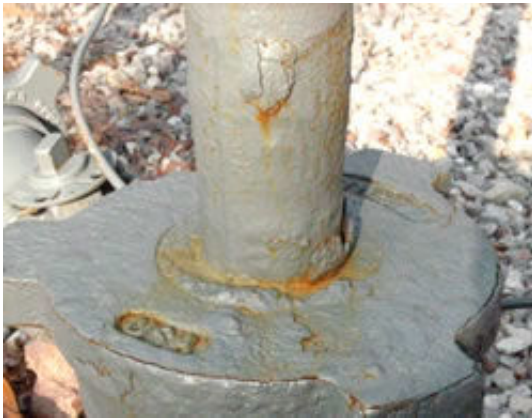
The severely corroded production pipe shown in the *Gas Well Study, 2009* report for 47-039-02026 still exists and poses a potentially serious safety issue, though it has now been painted.

The corroded production pipe at 47-039-02026 has been painted but is still in need of replacement.

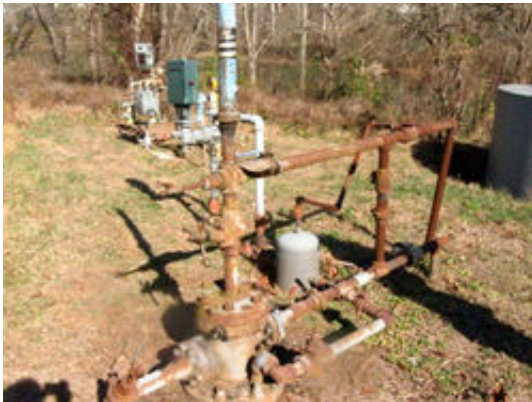
Corroded metal at 47-079-00570 needs to be painted.

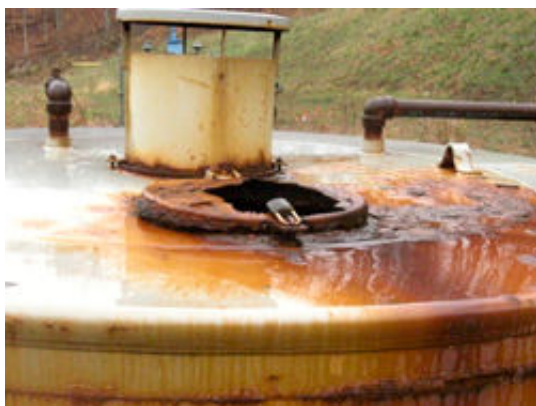
Rusted out storage tank trap doors were found at 47-079-01363 and 47-079-01299 (this is the trap door for 47-079-01363). The tanks affected are 50 barrel double-wall steel. It is hard to tell now much longer these tanks can last before they pose a threat to the environment.

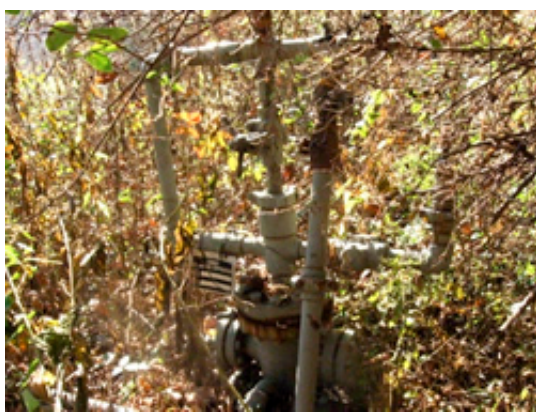
The pad and access road for 47-079-00601 were overgrown by weeds. We were not able to get close to the wellhead for that reason.

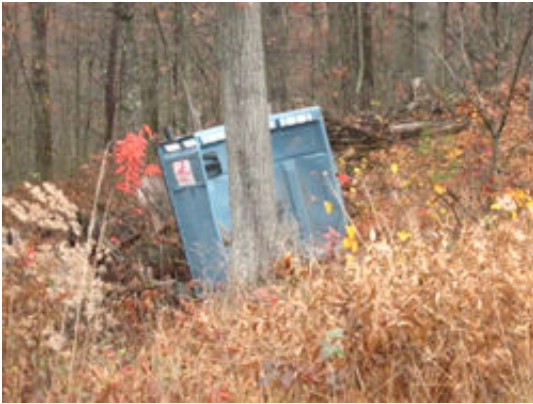
We did not note the presence of this portolet at 47-079-01314 when we visited in 2008.

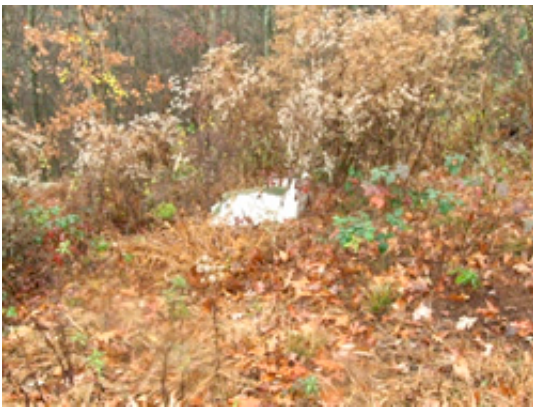
We noted a tipped-over portolet at the edge of 47-079-01364's pad in 2008. In our return visit we found pieces of the fiberglass structure scattered around the perimeter of the site.

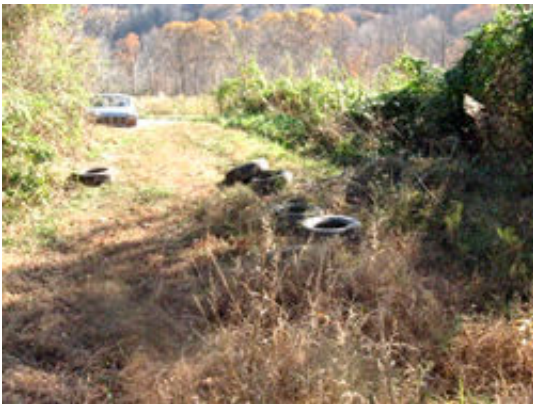
The well site for 47-079-00735 is directly off a busy paved public road and has no barrier to access. We noted dumping of trash in 2008 and again in 2010.

We feel that trash would not be left at well sites by others if well sites were properly secured by a gate.

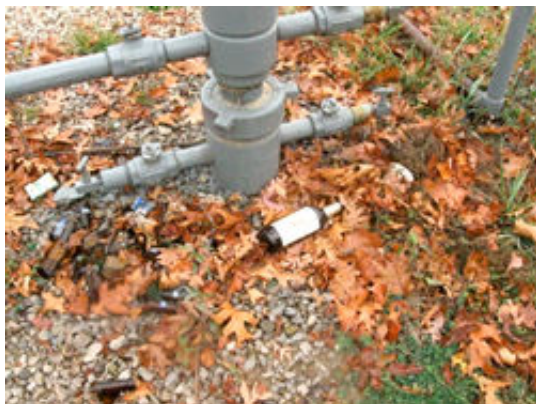
Unbroken and broken bottles at the wellhead of 47-079-01354 are evidence of the partying noted at a number of sites served by the Long Road.

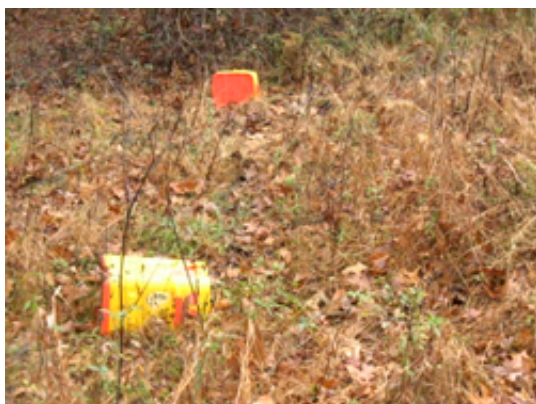
Two empty cat litter containers at the edge of 47-079-00706's pad were ambiguous. No other trash was seen at the site and it is impossible to tell if their presence is due to the operator or someone else.

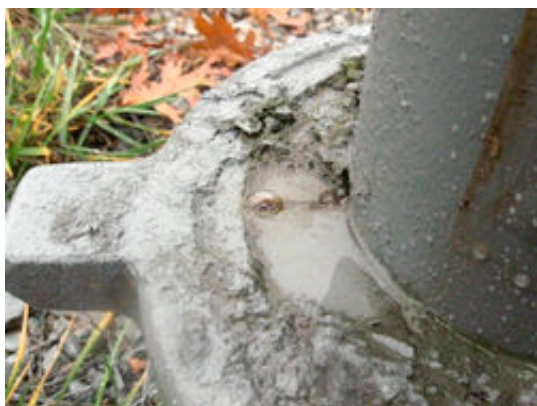
This is the casing head for 47-079-01314. What appear to be minor leaks of gas from the annulus were observed at 47-079-01299, 47-079-01314, and 47-079-01354.

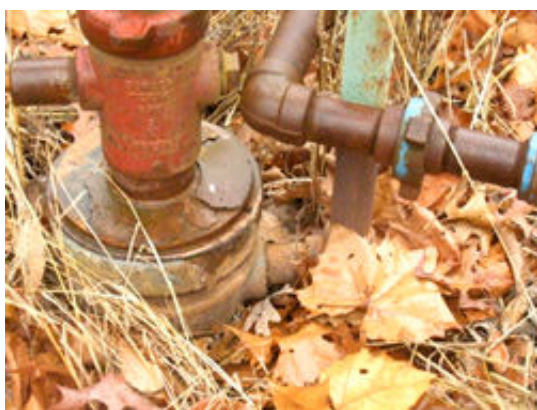
47-079-00702 had a special vent for gases from the annulus (the green pipe). The annulus appears to be highly pressurized and vents continually to the atmosphere above the wellhead. Strong, disorienting fumes had been present during our visit in 2008 and again in 2010.

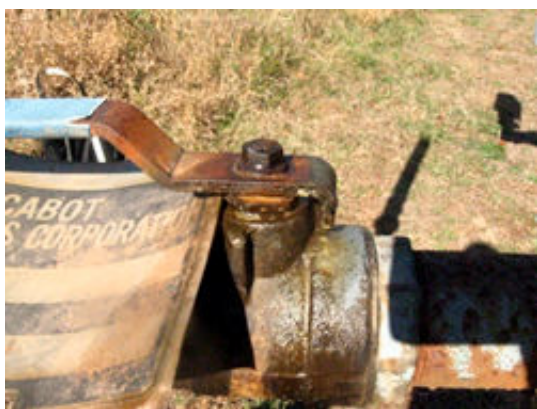
A fluid leak at a valve at 47-079-00570 was visible. Material was dripping onto the pipe below.

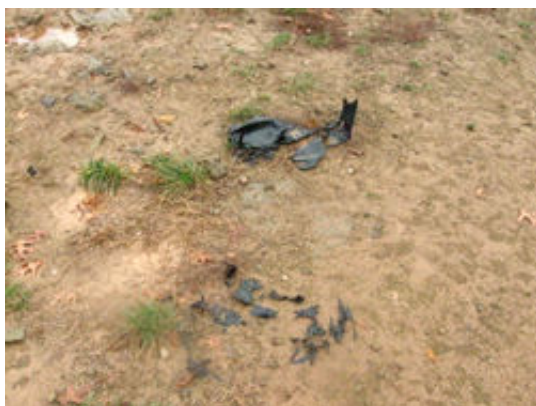
About 20% of this operator's wells visited since 2008 have exposed pit liner and this is one of those. A quick field test for chloride in a rain puddle near exposed liner showed 356 parts per million (ppm), demonstrating surface contamination from the buried solid pit waste. The state has no regulation or guidance for burial of solid pit waste but we believe it is not the state's intention that this waste be on the surface.⁴

Pieces of exposed black pit liner were observed at 47-079-01314 along a space of about 85 feet.

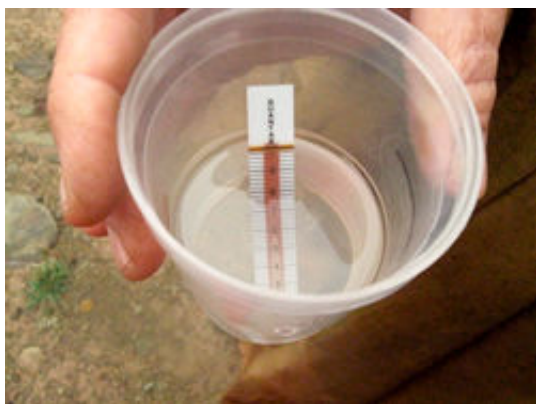
Chloride at 356 ppm was found in a rainwater puddle near the pieces of pit liner shown above.

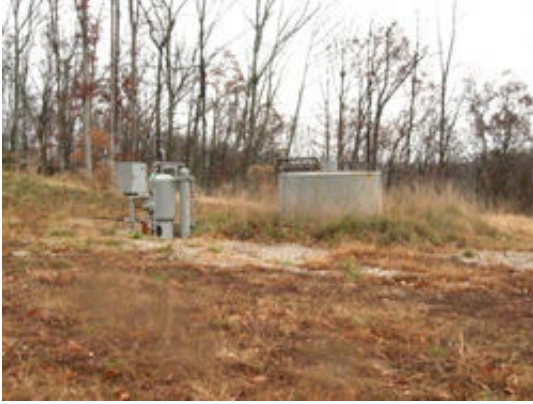
The pad for 47-079-01299 is sparsely vegetated.

We believe that surface tilling and reseeding would help those sites whose waste is buried under proper cover. We also believe that tall fescue is a poor choice for dry upland locations.

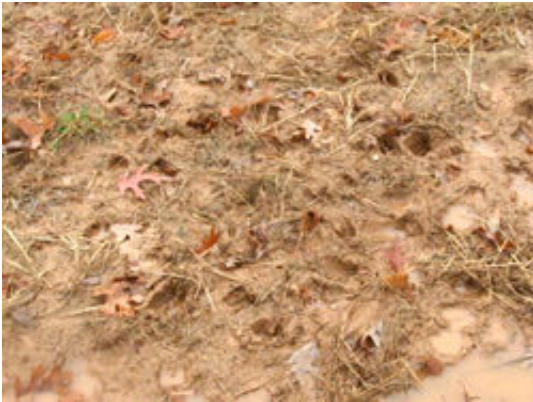
An unusual amount of deer tracking was seen at 47-079-01299 and a chloride concentration of 57 ppm was found in surface rainwater. We have yet to determine if the contamination is from a spill or signifies the presence of exposed pit waste.

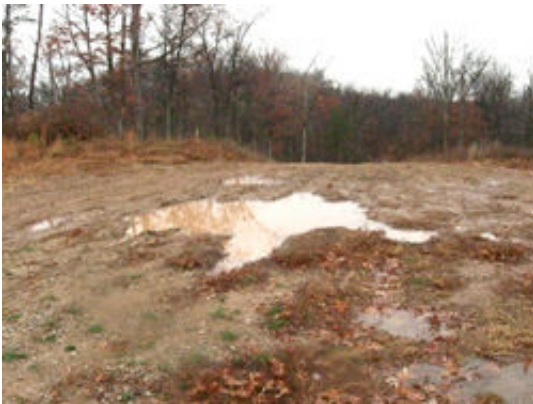
The pad for 47-079-01314 had large areas without vegetation. Rutting and potholes are caused by maintenance vehicle traffic.

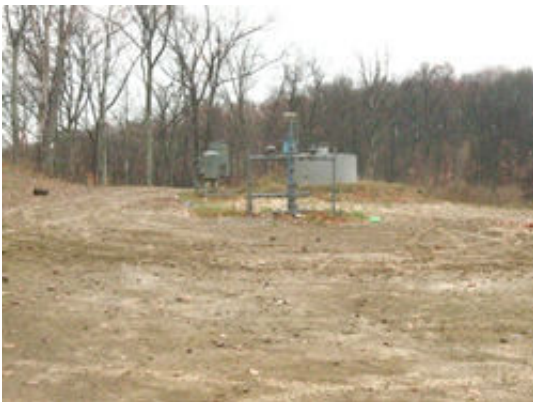
Poor vegetation was found at 47-079-01354 for both the pad and the cut slope.

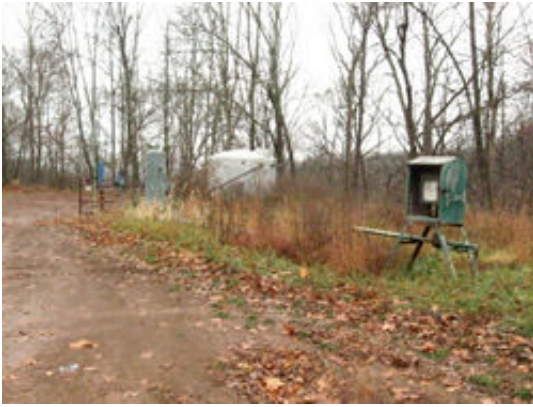
47-079-00702 only had vegetation near the wellhead and production piping. The rest of the large pad is bare, as it was in 2008.

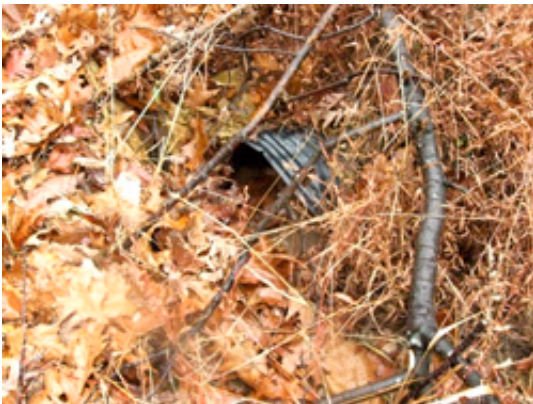
This same culvert at 47-079-01364 was partially blocked in 2008. No signs of corrective maintenance could be seen two years later.

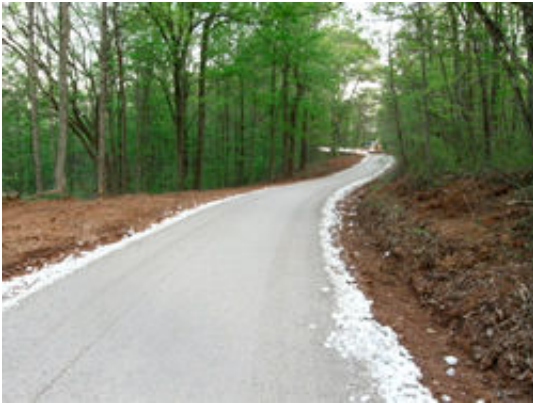
This is the freshly gravelled access road for 47-039-02026.

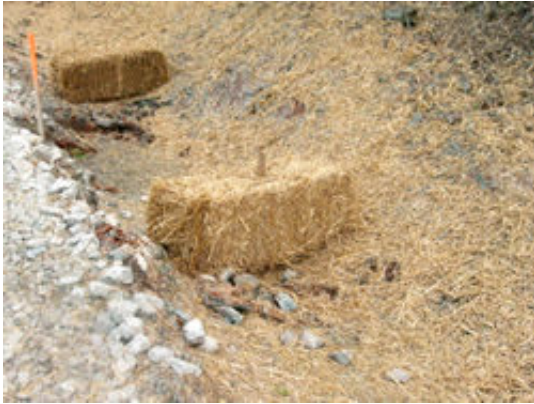
The contractor immediately hydroseeded and mulched the site after graveling the road. Straw bales were placed in a drainage ditch before a culvert inlet and again at the culvert outlet. Only one stake, not two as required, was used to install each bale and the bales were not set in the required anchor trenches. Compost socks are more appropriate for ditches like this.

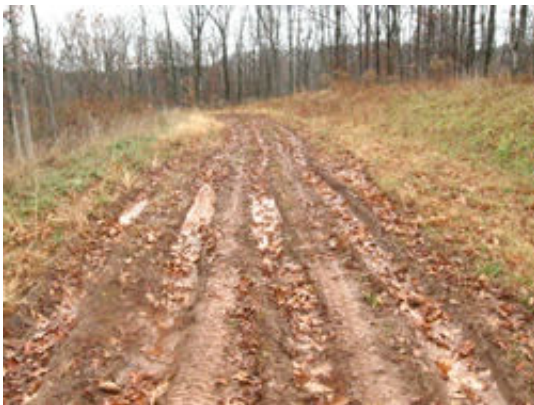
The road we call the Long Road well access road and well access spurs are in the same condition as the road for 47-039-02026 before renovation. Access is difficult when the road surface is wet or muddy. There are deep ruts and

potholes. Access has been so problematic in some locations that well tenders and other gas company vehicles have created long detours.

The well access road for 47-079-01299 off of the Long Road gives an idea of the state of the Long Road and its spurs.

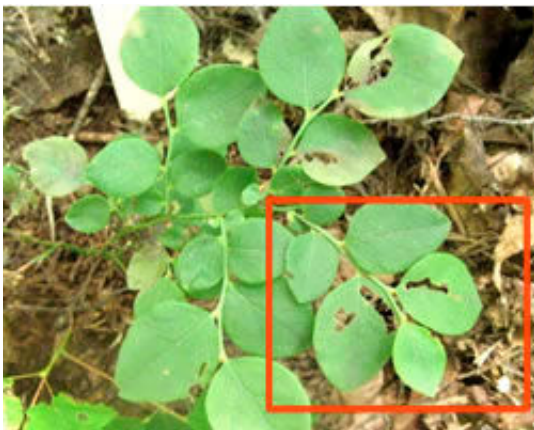
This photograph shows a study plant a day after application of a 5,000 mg/l chloride solution. The leaves within the red box were not touched by the solution. Some of the leaves outside the red box already show the effects from chloride by their color changes.

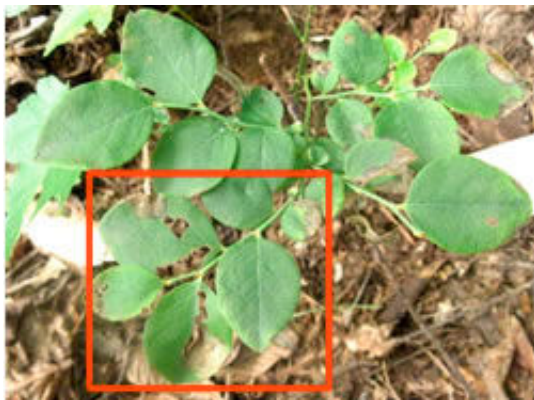
This photograph shows the same plant two weeks after application. Many of the leaves, especially those touched by the fluid, have fallen and most of the surviving leaves are showing signs of chlorosis.

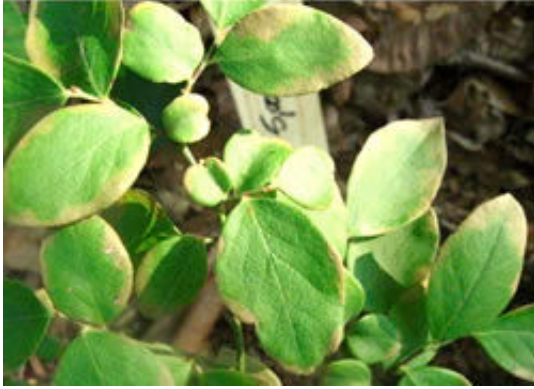
This is a different plant that also received a 5,000 mg/l chloride solution, except three times as much as the plant in the previous two photos. Signs of chlorosis are plain a week after application.

A smaller plant in the same application area was dead two weeks later and this plant had lost most of its leaves by then.
