Gas Well Study, 2013

George Monk and Molly Schaffnit
March 2014

Gas Well Study is the examination of natural gas wells in West Virginia.

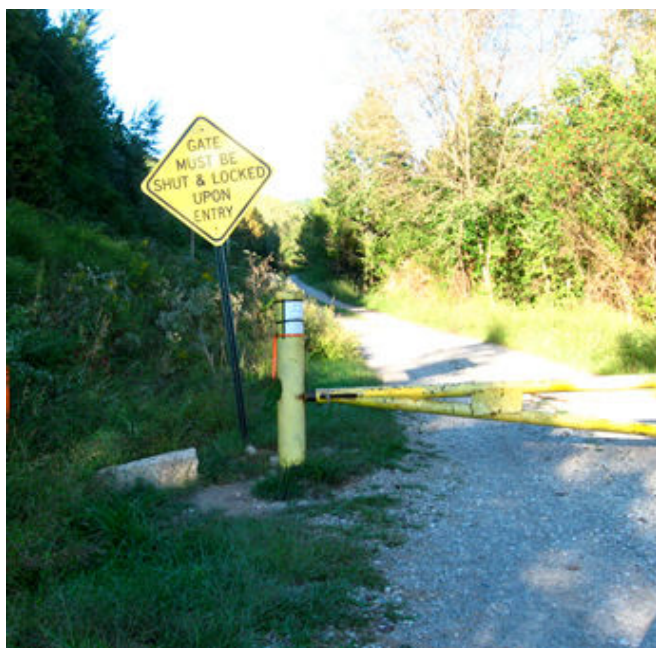
Photo 14. The entrance gate for the Plymouth Amherst WMA off Route 62. The gate is always kept locked. When we visited a vac truck passed us as we hiked into the WMA. It had just left the UIC class 2 well a mile beyond this gate. Photo taken on 23 September 2013.
