Gas Well Study, 2010

Reexamination of Some of the Wells Operated by One Company
Visited in 2008

George Monk and Molly Schaffnit
February 2011

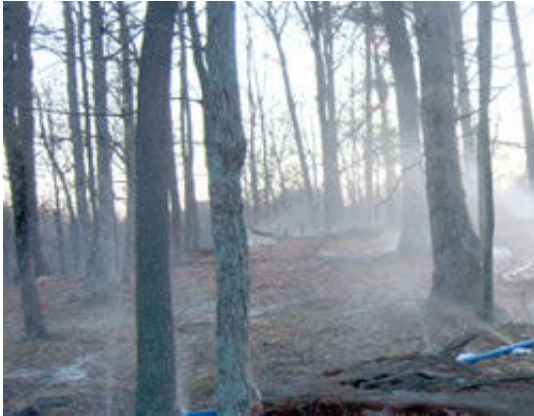
Land application of drill and fracture flowback in West Virginia is done by spraying the liquid over a vegetated area. It can be done, as here, by laying out perforated pipe or it can be done by a crew member holding a large diameter hose and moving about as the liquid sprays out over the application area.
